**Report No: AR/04/1695**

**VALLEY GARDENS MIDDLE SCHOOL  
VALLEY GARDENS, MONKSEATON  
WHITLEY BAY, TYNE AND WEAR**

**Survey to identify asbestos based materials  
carried out on behalf of North Tyneside Council**

**Issue Date: 22 April 2005**

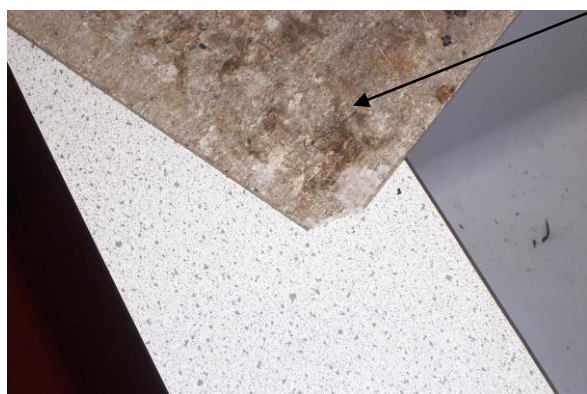
Classroom Science 1 – heatproof mats are an asbestos containing material (ACM sample BS/04). Although the material assessment is low it is recommended they be replaced with a non-asbestos alternative.

Similar heatproof mats can also be found in Main Building, Ground Floor, Classroom Science 2.

Level of ID	Sample ID	Extent (m <sup>2</sup> /m <sup>3</sup> )	Product Type (1,2,3)	Condition (0,1,2,3)	Surface Treatment (0,1,2,3)	Asbestos Type (1,2,3)	Score	Access (IA,OA,EA)	Action (A1,A2,A3)
ID	BS/04	2.5m <sup>2</sup>	2	3	0	1	5	EA	A2

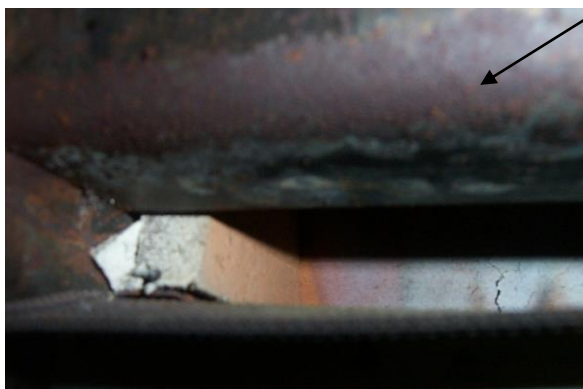
Kitchen – deep fat fryer internal insulation is an ACM (sample BS/07). It is in good condition and recommended to be left undisturbed and monitored.

Level of ID	Sample ID	Extent (m/m <sup>2</sup> /m <sup>3</sup> )	Product Type (1,2,3)	Condition (0,1,2,3)	Surface Treatment (0,1,2,3)	Asbestos Type (1,2,3)	Score	Access (IA,OA,EA)	Action (A1,A2,A3)
ID	BS/07	0.5m	2	1	1	2	6	OA	A3

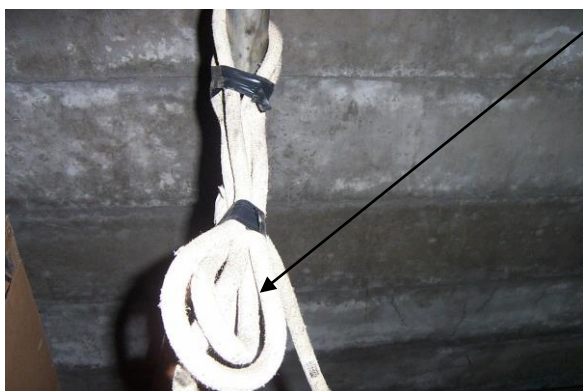
Stage – stage lighting cable sheath is an ACM (sample BS/11). It is in good condition and recommended it be left undisturbed and monitored.

Level of ID	Sample ID	Extent (m/m <sup>2</sup> /m <sup>3</sup> )	Product Type (1,2,3)	Condition (0,1,2,3)	Surface Treatment (0,1,2,3)	Asbestos Type (1,2,3)	Score	Access (IA,OA,EA)	Action (A1,A2,A3)
ID	BS/11	200m	2	0	3	1	6	OA	A3

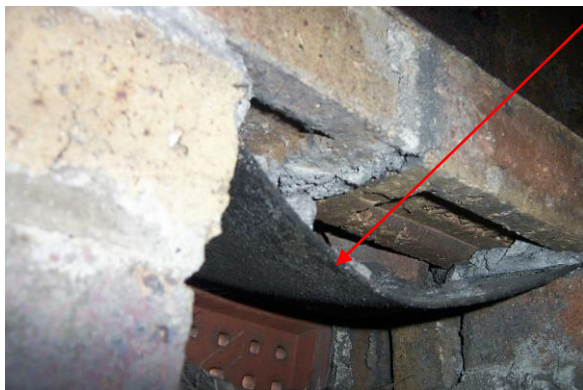
Tank Room – bitumen pads above and below air vents are an ACM (sample BS/14). They are in fair condition and recommended to be left undisturbed and monitored.

Level of ID	Sample ID	Extent (m <sup>2</sup> /m <sup>3</sup> )	Product Type (1,2,3)	Condition (0,1,2,3)	Surface Treatment (0,1,2,3)	Asbestos Type (1,2,3)	Score	Access (IA,OA,EA)	Action (A1,A2,A3)
ID	BS/14	5m <sup>2</sup>	1	0	0	1	2	OA	A3

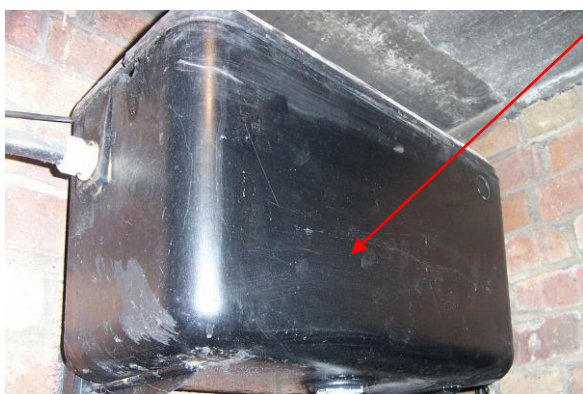
Boiler Room Toilet – toilet cistern is an ACM (sample BS/16). It is in good condition and unlikely to release any fibres during normal use.

Similar toilet cisterns can be found in First Year Block, Male Staff Toilet, First Year Block, Female Staff Toilet, First Year Block, Girls' Toilet and First Year Block, Boys' Toilet. It is recommended these be left undisturbed and monitored.

Level of ID	Sample ID	Extent (m <sup>2</sup> /m <sup>3</sup> )	Product Type (1,2,3)	Condition (0,1,2,3)	Surface Treatment (0,1,2,3)	Asbestos Type (1,2,3)	Score	Access (IA,OA,EA)	Action (A1,A2,A3)
ID	BS/16	0.5m <sup>2</sup>	1	0	0	2	3	OA	A3

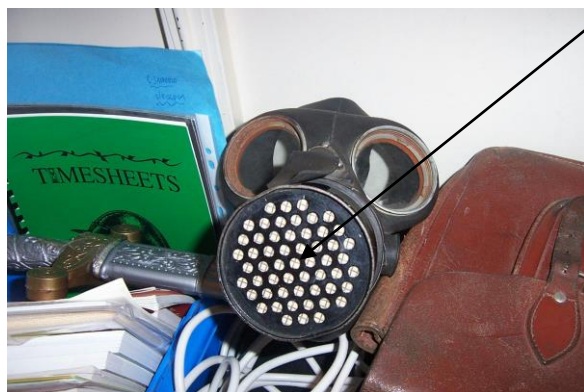
Store 25 – gas mask filter is presumed to be an ACM. Removal is recommended as soon as possible

Level of ID	Sample ID	Extent (m <sup>2</sup> /m <sup>3</sup> )	Product Type (1,2,3)	Condition (0,1,2,3)	Surface Treatment (0,1,2,3)	Asbestos Type (1,2,3)	Score	Access (IA,OA,EA)	Action (A1,A2,A3)
<i>P</i>	-	<0.25m <sup>2</sup>	3	0	2	3	8	EA	AI

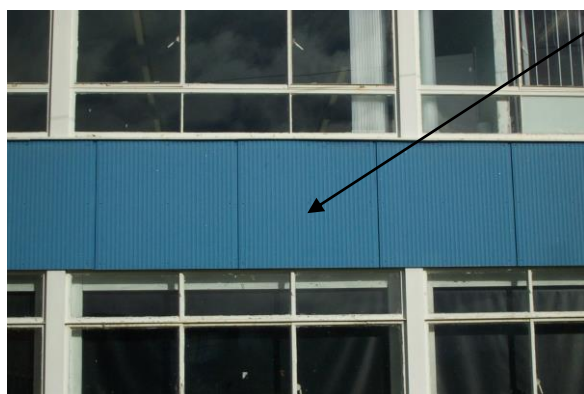
Exterior – fascia panels between floors are an ACM (sample BS/13). They are in good condition and recommended they be left undisturbed and monitored.

Similar panels can be found on Main Building, Exterior, Veranda ceiling.

Level of ID	Sample ID	Extent (m <sup>2</sup> /m <sup>3</sup> )	Product Type (1,2,3)	Condition (0,1,2,3)	Surface Treatment (0,1,2,3)	Asbestos Type (1,2,3)	Score	Access (IA,OA,EA)	Action (A1,A2,A3)
<i>ID</i>	<i>BS/13</i>	<i>120m<sup>2</sup></i>	<i>1</i>	<i>0</i>	<i>0</i>	<i>1</i>	<i>2</i>	<i>OA</i>	<i>A3</i>

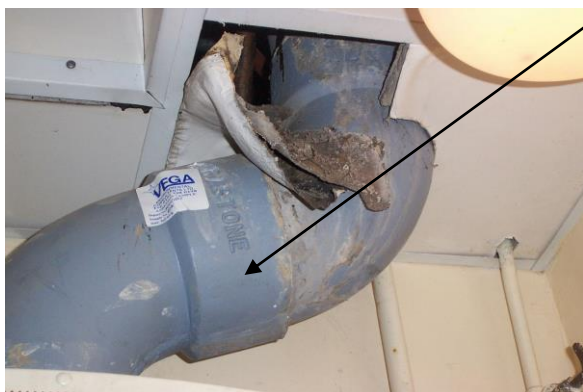
Male Staff Toilet – cement flue pipe is an ACM (sample BS/18). It is in good condition and recommended to be left undisturbed and monitored.

Similar flue pipes can be found in First Year Block, Girls’ Toilet, First Year Block, Boys’ Toilet, and First Year Block, Boiler Cupboards 1-3.

Level of ID	Sample ID	Extent (m/m <sup>2</sup> /m <sup>3</sup> )	Product Type (1,2,3)	Condition (0,1,2,3)	Surface Treatment (0,1,2,3)	Asbestos Type (1,2,3)	Score	Access (IA,OA,EA)	Action (A1,A2,A3)
ID	BS/18	4m	1	0	0	1	2	OA	A3

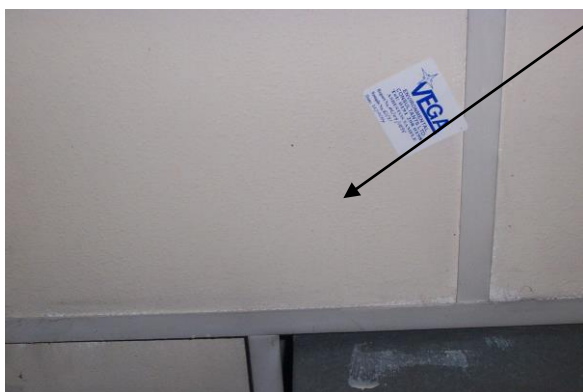
Boiler Cupboard 1 – ceiling panels are an ACM (sample BS/21). They are in very poor condition, it is recommended they be repaired and paint sealed in order to remain in place.

Similar panels can be found in First Year Block, Boiler Cupboards 2 and 3.

Level of ID	Sample ID	Extent (m/m <sup>2</sup> /m <sup>3</sup> )	Product Type (1,2,3)	Condition (0,1,2,3)	Surface Treatment (0,1,2,3)	Asbestos Type (1,2,3)	Score	Access (IA,OA,EA)	Action (A1,A2,A3)
ID	BS/21	2m <sup>2</sup>	2	3	2	2	9	OA	A2

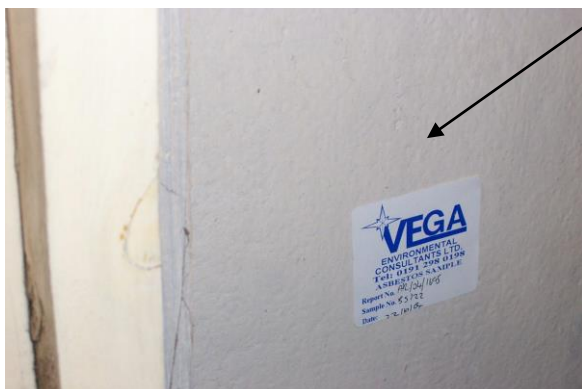
Boiler Cupboard 1 – wall panels are an ACM (sample BS/22). They are in poor condition and it is recommended they be repaired and paint sealed in order to remain in place.

Similar panels can be found in First Year Block, Boiler Cupboards 2 and 3.

Level of ID	Sample ID	Extent (m <sup>2</sup> /m <sup>3</sup> )	Product Type (1,2,3)	Condition (0,1,2,3)	Surface Treatment (0,1,2,3)	Asbestos Type (1,2,3)	Score	Access (IA,OA,EA)	Action (A1,A2,A3)
ID	BS/22	9.5m <sup>2</sup>	2	2	2	2	8	OA	A2

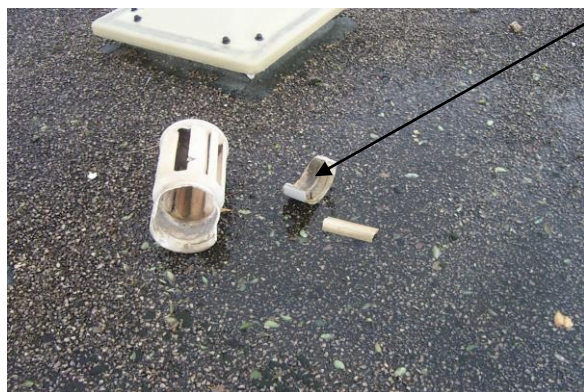
Exterior – cement cowl debris is an ACM (sample as BS/23). Removal is recommended as soon as possible.

Level of ID	Sample ID	Extent (m/m <sup>2</sup> /m <sup>3</sup> )	Product Type (1,2,3)	Condition (0,1,2,3)	Surface Treatment (0,1,2,3)	Asbestos Type (1,2,3)	Score	Access (IA,OA,EA)	Action (A1,A2,A3)
SP	As BS/23	0.5m <sup>2</sup>	3	3	3	1	10	OA	A1

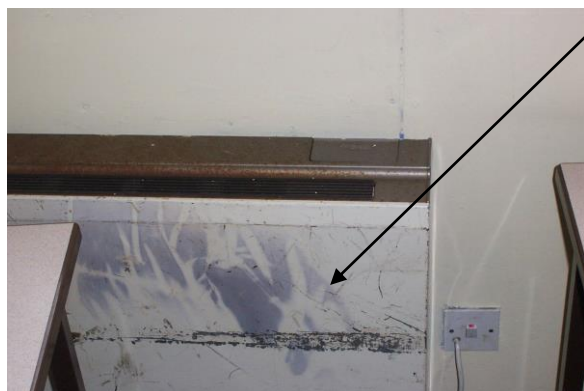
Classroom – wall mounted heater was inaccessible (live), therefore, we must presume it contains asbestos. It is recommended that a closer inspection is undertaken prior to any invasive maintenance works

Level of ID	Sample ID	Extent (m/m <sup>2</sup> /m <sup>3</sup> )	Product Type (1,2,3)	Condition (0,1,2,3)	Surface Treatment (0,1,2,3)	Asbestos Type (1,2,3)	Score	Access (IA,OA,EA)	Action (A1,A2,A3)
P	-	<1m <sup>2</sup>	2	0	2	2	6	IA	A3

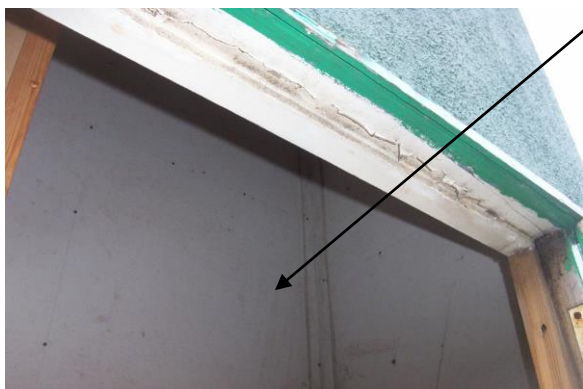
Gas Bottle Store – ceiling, walls and floor panels are an ACM (sample BS/25). They are in good condition, however, it is recommended they be repaired and paint sealed in order to remain in place.

Level of ID	Sample ID	Extent (m <sup>2</sup> /m <sup>3</sup> )	Product Type (1,2,3)	Condition (0,1,2,3)	Surface Treatment (0,1,2,3)	Asbestos Type (1,2,3)	Score	Access (IA,OA,EA)	Action (A1,A2,A3)
ID	BS/25	4m <sup>2</sup>	2	1	2	2	7	OA	A2

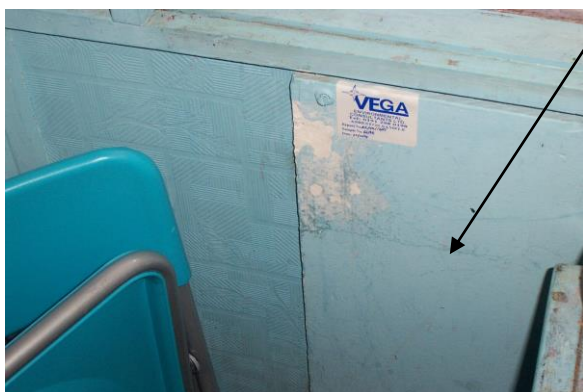
Classroom – panel behind wall mounted heater is an ACM (sample BS/26). It is in good condition, however, it is recommended it be repaired and paint sealed in order to remain in place.

Level of ID	Sample ID	Extent (m <sup>2</sup> /m <sup>3</sup> )	Product Type (1,2,3)	Condition (0,1,2,3)	Surface Treatment (0,1,2,3)	Asbestos Type (1,2,3)	Score	Access (IA,OA,EA)	Action (A1,A2,A3)
ID	BS/26	1m <sup>2</sup>	2	0	1	2	5	EA	A2
