North Tyneside Council

Asbestos Survey Report 27/05/2014-30/05/2014 Management Survey

000047090890
Valley Gardens Middle
Valley Gardens
Whitley Bay
Tyne and Wear
NE25 9AQ

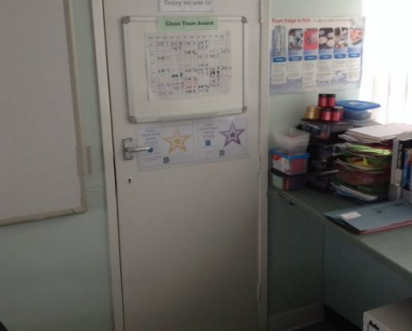
No access beneath linoleum flooring due to excessive damage. Electrical switch gear.

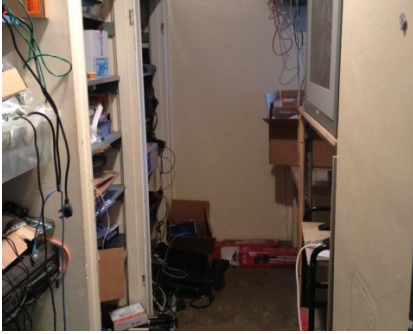
No access beneath carpet due to excessive damage.

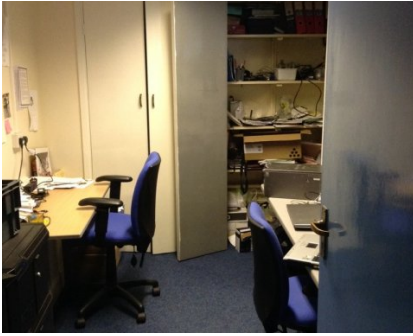
No access beneath carpet due to excessive damage.

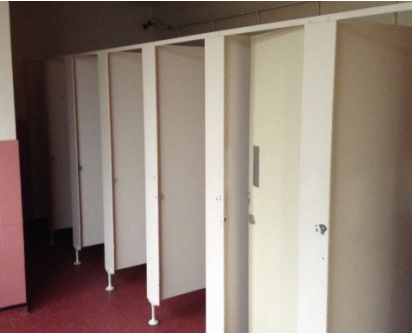
No access beneath carpet due to excessive damage. No access within timber boxing.

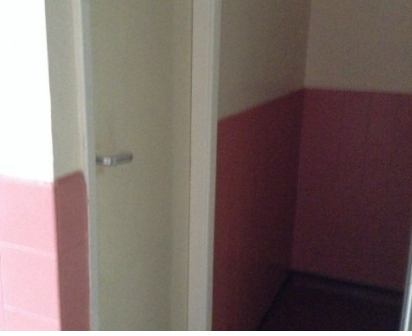
No access beneath linoleum due to excessive damage.

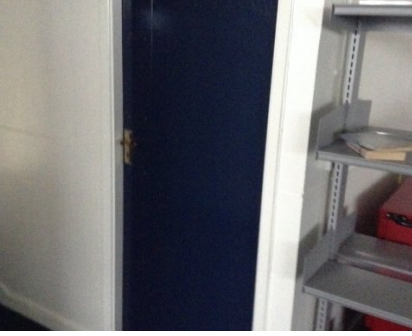
No access beneath carpet due to excessive damage.

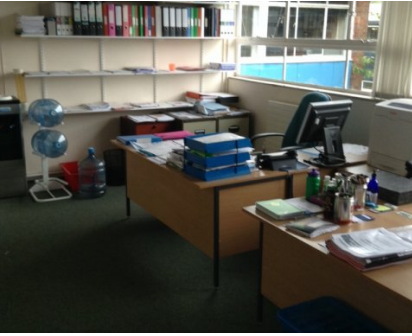
No access beneath carpet due to excessive damage.

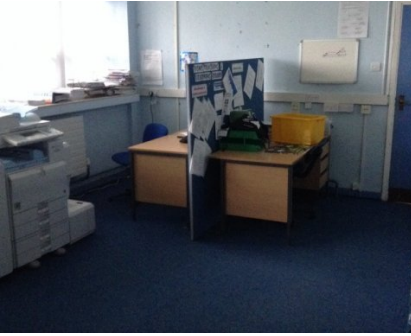
No access beneath carpet due to excessive damage.

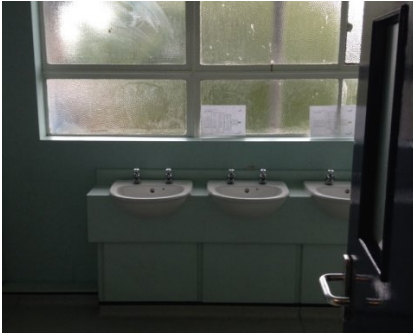
No access beneath carpet due to excessive damage.

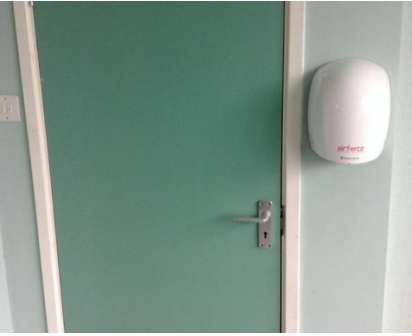
No access beneath linoleum due to excessive damage. No access within timber boxing.

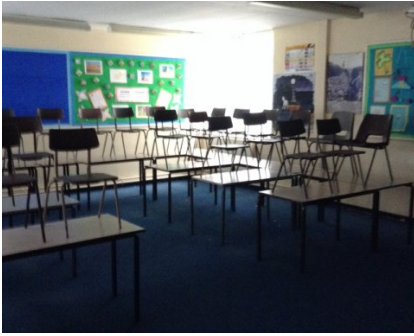
No access beneath carpet due to excessive damage.

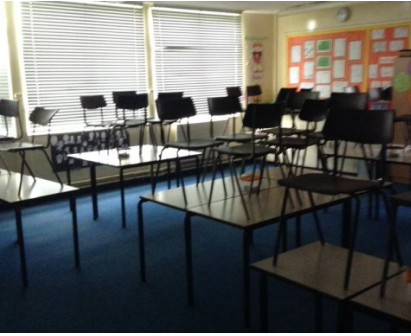
No access beneath carpet due to excessive damage.

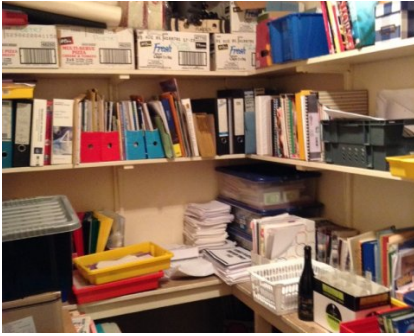
No access beneath carpet due to excessive damage.

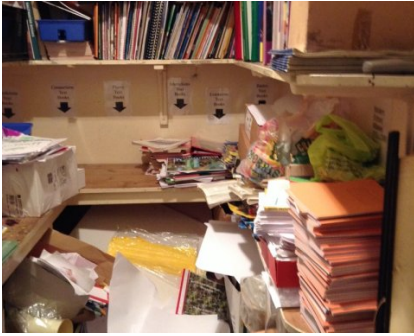
No access beneath carpet due to excessive damage.

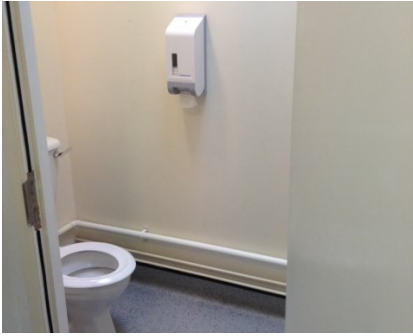
No access beneath linoleum flooring due to excessive damage. Limited access within roof void.

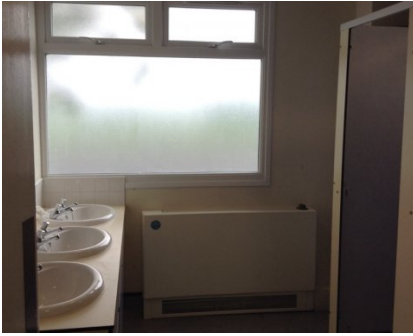
No access beneath linoleum flooring due to excessive damage. Limited access within roof void.

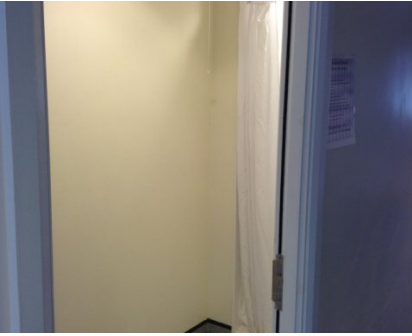
No access beneath linoleum flooring due to excessive damage. Limited access within roof void. No access within timber boxing.

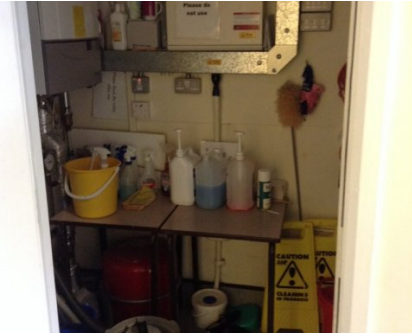
No access beneath linoleum flooring due to excessive damage. Limited access within roof void.

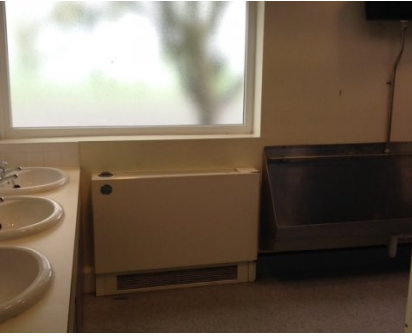
No access beneath linoleum flooring due to excessive damage. Limited access within roof void. MMMF insulated pipe work. Remeha Quinta gas boiler.

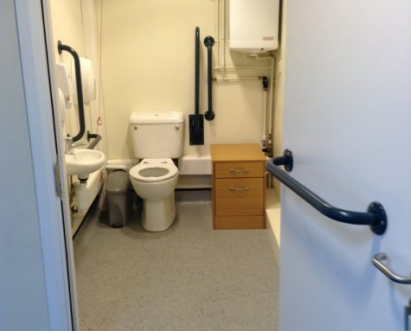
No access beneath linoleum flooring due to excessive damage. Limited access within roof void. Plastic cistern. No access within timber box work due to excessive damage.

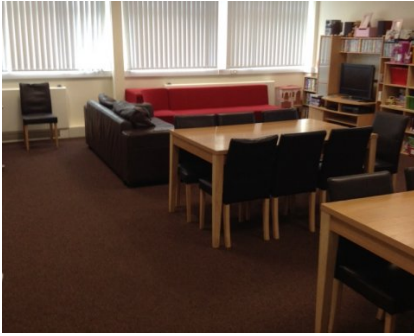
No access beneath linoleum flooring due to excessive damage. Limited access within roof void. No access within timber box work due to excessive damage.

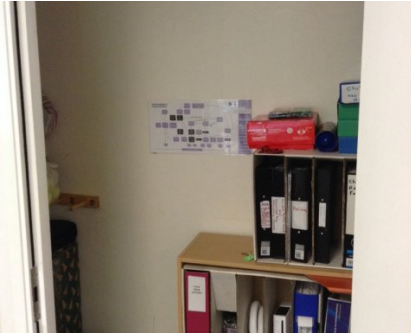
No access within timber box work due to excessive damage.

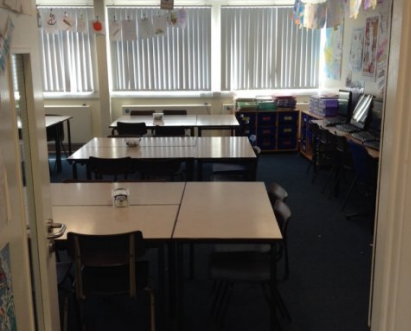
No access beneath linoleum flooring due to excessive damage. Limited access within roof void. Modern kitchen units.

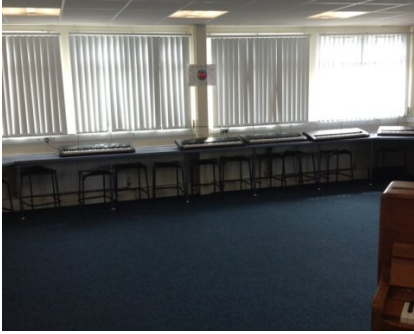
No access within timber box work due to excessive damage.

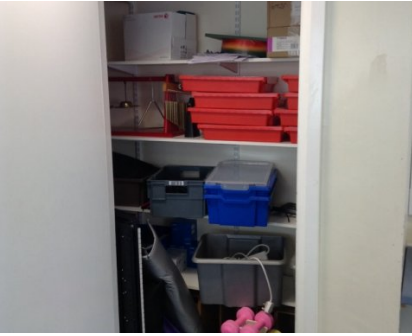
No access within timber box work due to excess damage.

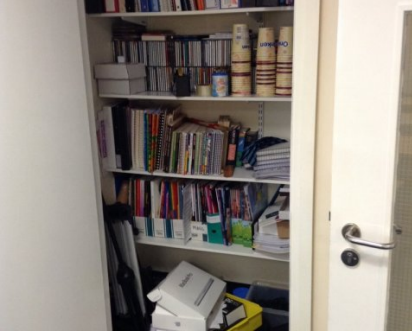
No access within timber box work due to excess damage.
