Report No: AR/07/2952

**MONKSEATON MIDDLE SCHOOL
VERNON DRIVE
WHITLEY BAY**

**Survey to identify asbestos based materials
carried out on behalf of North Tyneside Council**

Issue Date: 14 November 2007

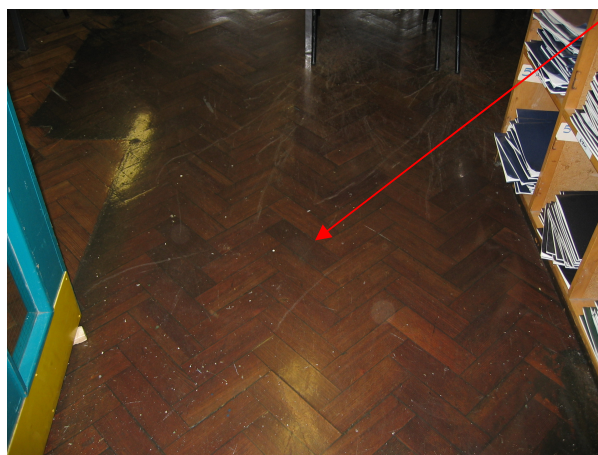
Room 14 – parquet flooring over bitumen adhesive was inaccessible without causing damage; therefore, we must presume it contains asbestos. It is recommended a further inspection take place prior to any refurbishment work.

Similar parquet flooring adhesive can be found in rooms 13, 12, 11 and the hall. Refer to asbestos register, pages 4 and 5.

Level of ID	Sample ID	Extent (m ² /m ³)	Product Type (1,2,3)	Condition (0,1,2,3)	Surface Treatment (0,1,2,3)	Asbestos Type (1,2,3)	Score	Access (IA,OA,EA)	Action (A1,A2,A3)
P	-	60m ²	1	0	0	1	2	IA	A3

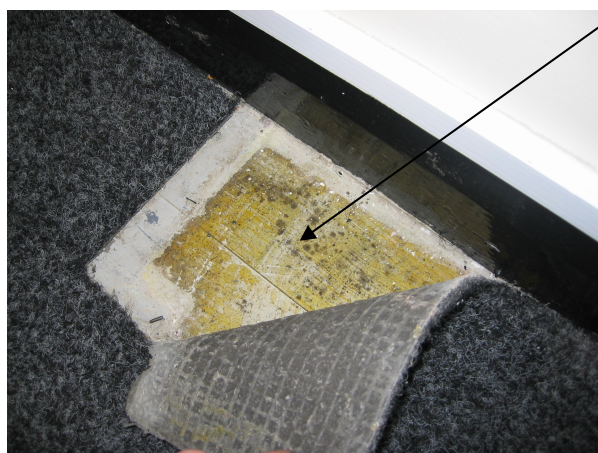
Room 9 – vinyl floor tiles are an asbestos containing material (ACM sample BS/02). They are in good condition and recommended they be left undisturbed and monitored.

Similar vinyl floor tiles can be found throughout the surveyed area. Refer to asbestos register, pages 4 and 5.

Level of ID	Sample ID	Extent (m ² /m ³)	Product Type (1,2,3)	Condition (0,1,2,3)	Surface Treatment (0,1,2,3)	Asbestos Type (1,2,3)	Score	Access (IA,OA,EA)	Action (A1,A2,A3)
<i>ID</i>	<i>BS/02</i>	<i>60m²</i>	<i>1</i>	<i>0</i>	<i>0</i>	<i>1</i>	<i>2</i>	<i>OA</i>	<i>A3</i>

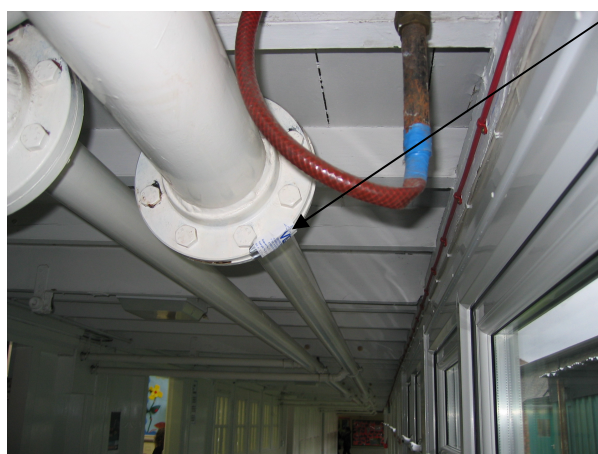
Corridor 8 – pipe flange gaskets are an ACM (sample BS/08). They are in good condition and recommended they be left undisturbed and monitored.

Similar pipe flange gaskets can also be found in corridor 9 and boiler room. Refer to asbestos register, pages 4 and 5.

Level of ID	Sample ID	Extent (m ² /m ³)	Product Type (1,2,3)	Condition (0,1,2,3)	Surface Treatment (0,1,2,3)	Asbestos Type (1,2,3)	Score	Access (IA,OA,EA)	Action (A1,A2,A3)
<i>ID</i>	<i>BS/08</i>	<i>1m</i>	<i>2</i>	<i>0</i>	<i>0</i>	<i>1</i>	<i>3</i>	<i>OA</i>	<i>A3</i>

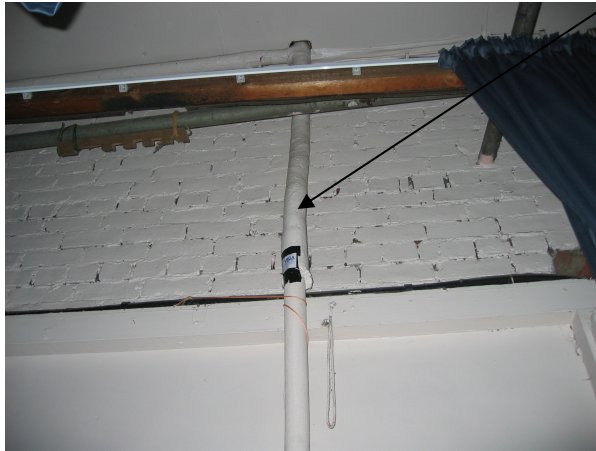
Stage Area – pipe insulation is an ACM (sample BS/14). Due to the medium damage and occasional access, it is recommended it be enclosed behind mechanical protection (e.g. sheet metal cladding) is required in order for it to remain in place, subject to routine surveillance monitoring. Removal and replacement with a non-asbestos alternative may be a more appropriate action.

Level of ID	Sample ID	Extent (m/m ² /m ³)	Product Type (1,2,3)	Condition (0,1,2,3)	Surface Treatment (0,1,2,3)	Asbestos Type (1,2,3)	Score	Access (IA,OA,EA)	Action (A1,A2,A3)
ID	BS/14	8m	3	2	2	2	9	OA	A2

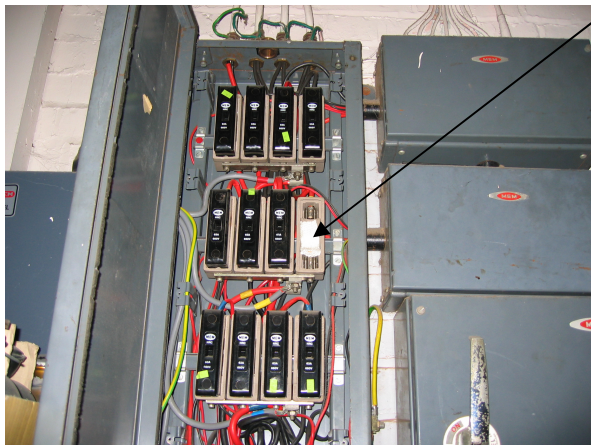
Stage Area – electrical equipment fuse flash guards are an ACM (sample BS/15). They are in good condition and recommended they be left undisturbed and monitored.

Level of ID	Sample ID	Extent (m/m ² /m ³)	Product Type (1,2,3)	Condition (0,1,2,3)	Surface Treatment (0,1,2,3)	Asbestos Type (1,2,3)	Score	Access (IA,OA,EA)	Action (A1,A2,A3)
ID	BS/15	<1m	2	0	0	1	3	OA	A3

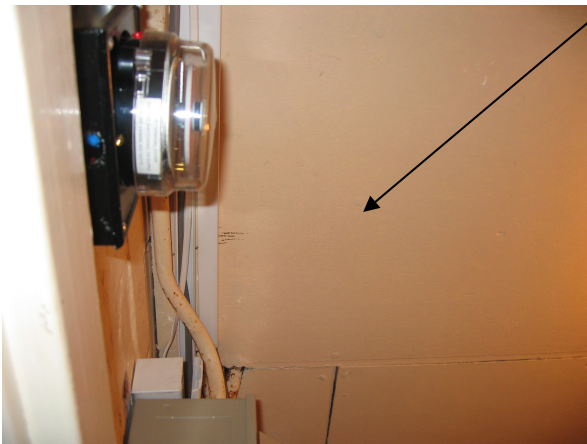
Cleaners Cupboard 1 – ceiling panels are an ACM (sample BS/12). They are in good condition and recommended they be left undisturbed and monitored.

Similar ceiling panels can be found throughout the surveyed area. Refer to asbestos register, pages 4 and 5.

Level of ID	Sample ID	Extent (m/m ² /m ³)	Product Type (1,2,3)	Condition (0,1,2,3)	Surface Treatment (0,1,2,3)	Asbestos Type (1,2,3)	Score	Access (IA,OA,EA)	Action (A1,A2,A3)
<i>ID</i>	<i>BS/12</i>	<i>2m²</i>	<i>2</i>	<i>0</i>	<i>1</i>	<i>2</i>	<i>5</i>	<i>IA</i>	<i>A3</i>

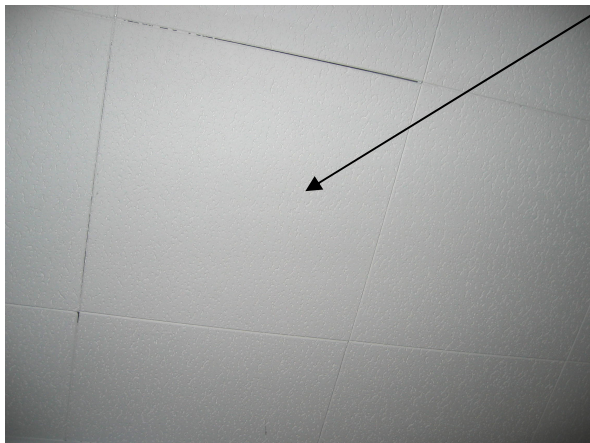
Library – void above was inaccessible (without causing damage to interlocking tiles) therefore; we must presume it contains asbestos. It is recommended a further inspection take place prior to any refurbishment work.

Level of ID	Sample ID	Extent (m/m ² /m ³)	Product Type (1,2,3)	Condition (0,1,2,3)	Surface Treatment (0,1,2,3)	Asbestos Type (1,2,3)	Score	Access (IA,OA,EA)	Action (A1,A2,A3)
<i>P</i>	<i>-</i>	<i>-</i>	<i>-</i>	<i>-</i>	<i>-</i>	<i>-</i>	<i>-</i>	<i>IA</i>	<i>A3</i>

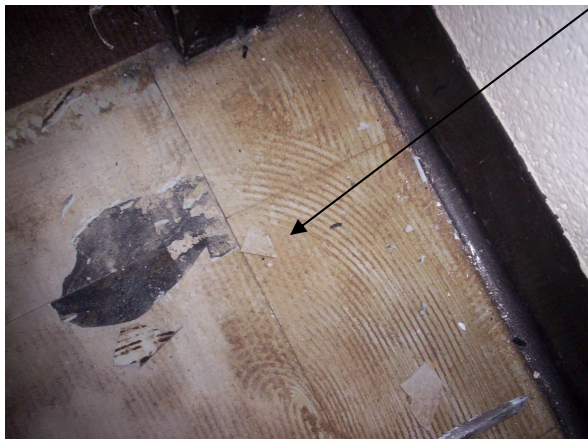
Room 17 – vinyl floor tiles are an ACM (sample BS/13). They are in good condition and recommended they be left undisturbed and monitored.

Similar vinyl floor tiles can be found throughout the surveyed area. Refer to asbestos register, pages 4 and 5.

Level of ID	Sample ID	Extent (m ² /m ³)	Product Type (1,2,3)	Condition (0,1,2,3)	Surface Treatment (0,1,2,3)	Asbestos Type (1,2,3)	Score	Access (IA,OA,EA)	Action (A1,A2,A3)
ID	BS/13	36m ²	1	0	0	1	2	IA	A3

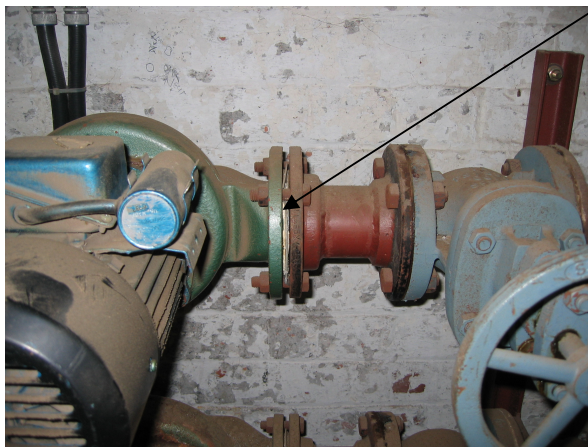
Boiler Room – green pipe flange gaskets in various locations are an ACM (sample BS/17). They are in good condition and recommended they be left undisturbed and monitored.

Level of ID	Sample ID	Extent (m ² /m ³)	Product Type (1,2,3)	Condition (0,1,2,3)	Surface Treatment (0,1,2,3)	Asbestos Type (1,2,3)	Score	Access (IA,OA,EA)	Action (A1,A2,A3)
ID	BS/17	<0.5m	2	0	0	1	3	IA	A3

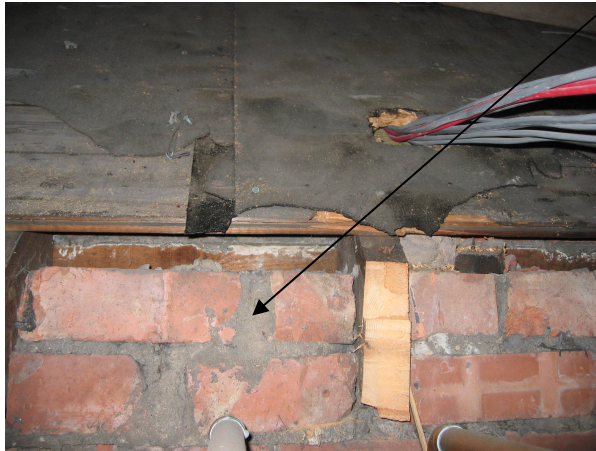
Boiler Room – insulation splatter to wall is an ACM (sample BS/18). It is in poor condition and recommended it be removed as soon as possible.

Level of ID	Sample ID	Extent (m/m ² /m ³)	Product Type (1,2,3)	Condition (0,1,2,3)	Surface Treatment (0,1,2,3)	Asbestos Type (1,2,3)	Score	Access (IA,OA,EA)	Action (A1,A2,A3)
<i>ID</i>	<i>BS/18</i>	<i>Unqualifiable</i>	<i>3</i>	<i>3</i>	<i>3</i>	<i>1</i>	<i>10</i>	<i>EA</i>	<i>A1</i>

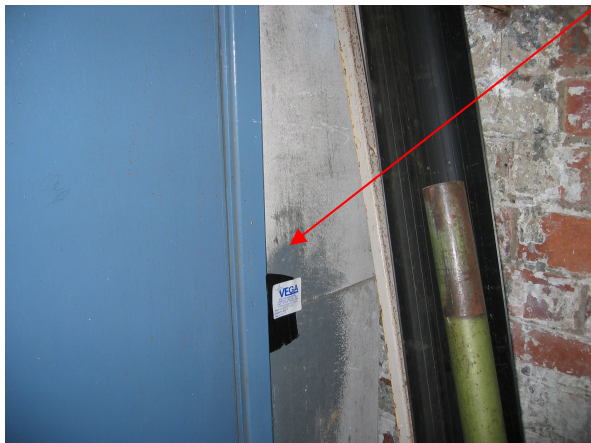
Boiler Room – wall panels to store room are an ACM (sample BS/19). Due to the ease of access to this material encapsulation behind mechanical protection (e.g. sheet metal cladding) is required in order for it to remain in place, subject to routine surveillance monitoring. Removal and replacement with a non-asbestos alternative may be a more appropriate action.

Level of ID	Sample ID	Extent (m/m ² /m ³)	Product Type (1,2,3)	Condition (0,1,2,3)	Surface Treatment (0,1,2,3)	Asbestos Type (1,2,3)	Score	Access (IA,OA,EA)	Action (A1,A2,A3)
<i>ID</i>	<i>BS/19</i>	<i><2m²</i>	<i>2</i>	<i>0</i>	<i>2</i>	<i>2</i>	<i>6</i>	<i>EA</i>	<i>A2</i>

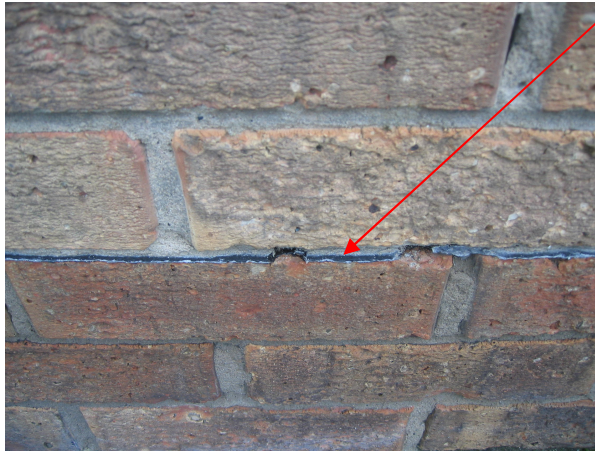
Exterior – damp proof course is an ACM (sample BS/23). It is recommended it be left in place, subject to routine surveillance monitoring until such time that the building is demolished.

Level of ID	Sample ID	Extent (m/m ² /m ³)	Product Type (1,2,3)	Condition (0,1,2,3)	Surface Treatment (0,1,2,3)	Asbestos Type (1,2,3)	Score	Access (IA,OA,EA)	Action (A1,A2,A3)
ID	BS/23	800m	1	0	0	1	2	IA	A3
