## North Tyneside Council

### Asbestos Survey Report 22/07/2013 Management Survey

000047091283  
Monkseaton Middle  
Vernon Drive  
Monkseaton  
Tyne and Wear  
NE25 9AQ

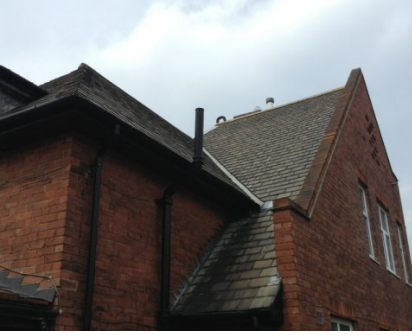
Room/location Reference:	Roof
Room/location Description:	
Area/floor Reference:	External
Area/floor Description:	
Accessibility:	Inaccessible
Reason for No Access:	Height Restriction
Total ACMs:	0
Total NoACMs:	0

Slate Roof with UPVC and Cast Iron Rain Goods/down Pipes. Timber Facials and Soffits

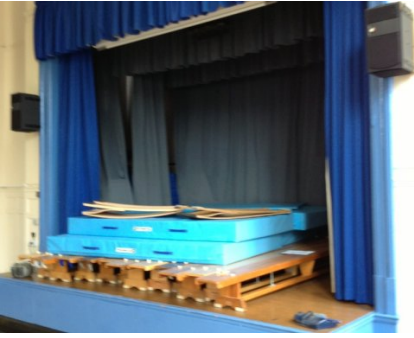
Room/location Reference:	Room 24
Room/location Description:	Stage
Area/floor Reference:	Ground Floor
Area/floor Description:	
Accessibility:	Accessible
Total ACMs:	2
Total NoACMs:	0

Product Type (a)	N/A
Extent of Damage (b)	N/A
Surface Treatment (c)	N/A
Asbestos Fibre (d)	N/A
Total (a+b+c+d)	12
Material Risk Assessment	<span style="color: red;">■</span> High

Product Type (a)	1
Extent of Damage (b)	0
Surface Treatment (c)	2
Asbestos Fibre (d)	1
Total (a+b+c+d)	04
Material Risk Assessment	<span style="color: yellow;">■</span> Very Low

Action/recommendations	Further Investigation Required
------------------------	--------------------------------

Action/recommendations	Monitor
------------------------	---------

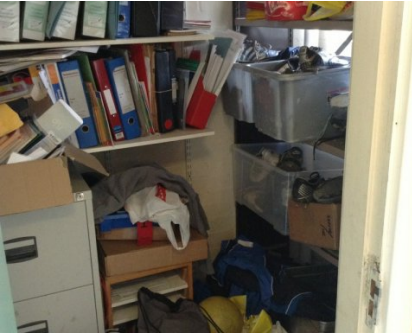
Product Type (a)	2
Extent of Damage (b)	1
Surface Treatment (c)	1
Asbestos Fibre (d)	2
Total (a+b+c+d)	06
Material Risk Assessment	<span style="color: orange;">■</span> Low

Action/recommendations	Encapsulate & Label
------------------------	---------------------

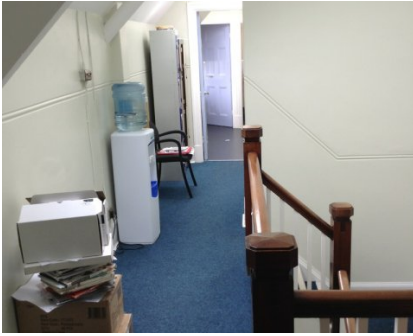
Product Type (a)	2
Extent of Damage (b)	1
Surface Treatment (c)	1
Asbestos Fibre (d)	2
Total (a+b+c+d)	06
Material Risk Assessment	<span style="color: orange;">■</span> Low

Action/recommendations	Encapsulate & Label
------------------------	---------------------

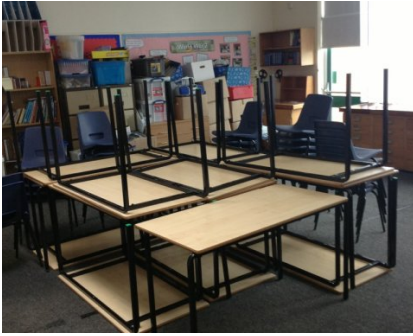
Product Type (a)	2
Extent of Damage (b)	1
Surface Treatment (c)	1
Asbestos Fibre (d)	2
Total (a+b+c+d)	06
Material Risk Assessment	<span style="color: orange;">■</span> Low

Action/recommendations	Encapsulate & Label
------------------------	---------------------

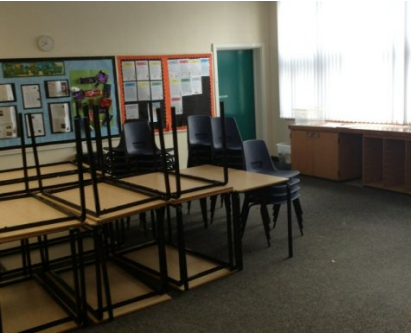
Product Type (a)	1
Extent of Damage (b)	0
Surface Treatment (c)	0
Asbestos Fibre (d)	1
Total (a+b+c+d)	02
Material Risk Assessment	<span style="color: yellow;">■</span> Very Low

Action/recommendations	Monitor
------------------------	---------

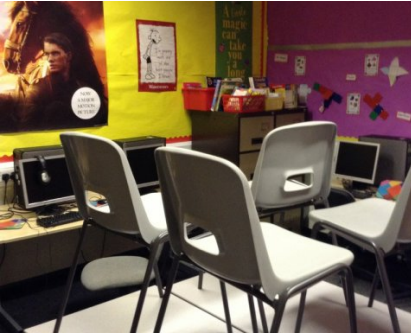
Product Type (a)	2
Extent of Damage (b)	1
Surface Treatment (c)	1
Asbestos Fibre (d)	2
Total (a+b+c+d)	06
Material Risk Assessment	<span style="color: orange;">■</span> Low

Product Type (a)	1
Extent of Damage (b)	0
Surface Treatment (c)	0
Asbestos Fibre (d)	1
Total (a+b+c+d)	02
Material Risk Assessment	<span style="color: yellow;">■</span> Very Low

Action/recommendations	Encapsulate & Label
------------------------	---------------------

Action/recommendations	Monitor
------------------------	---------

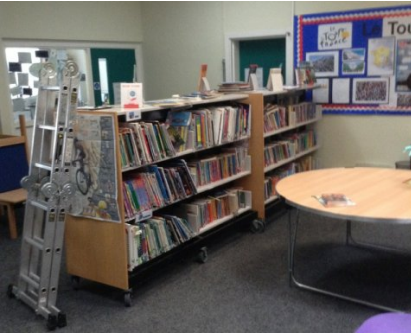
Product Type (a)	2
Extent of Damage (b)	1
Surface Treatment (c)	1
Asbestos Fibre (d)	2
Total (a+b+c+d)	06
Material Risk Assessment	<span style="color: orange;">■</span> Low

Product Type (a)	1
Extent of Damage (b)	0
Surface Treatment (c)	0
Asbestos Fibre (d)	1
Total (a+b+c+d)	02
Material Risk Assessment	<span style="color: yellow;">■</span> Very Low

Action/recommendations	Encapsulate & Label
------------------------	---------------------

Action/recommendations	Monitor
------------------------	---------

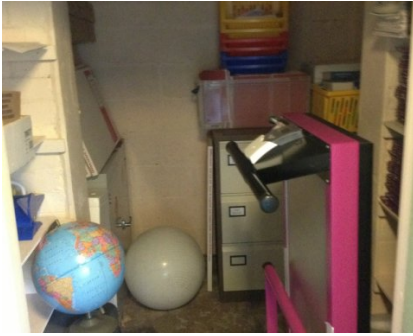
Product Type (a)	2
Extent of Damage (b)	1
Surface Treatment (c)	1
Asbestos Fibre (d)	2
Total (a+b+c+d)	06
Material Risk Assessment	<span style="color: orange;">■</span> Low

Action/recommendations	Encapsulate & Label
------------------------	---------------------
