Murton Gap Strategic Development Allocation Draft Heritage Statement

July 2015 (revised May 2016)

Title	Murton Gap Strategic Development Allocation Heritage Statement	
Date	Original version July 2015 Revised May 2016	
Project Code		
Client	North Tyneside Council	
Prepared by	Laura Hewitt	Signature

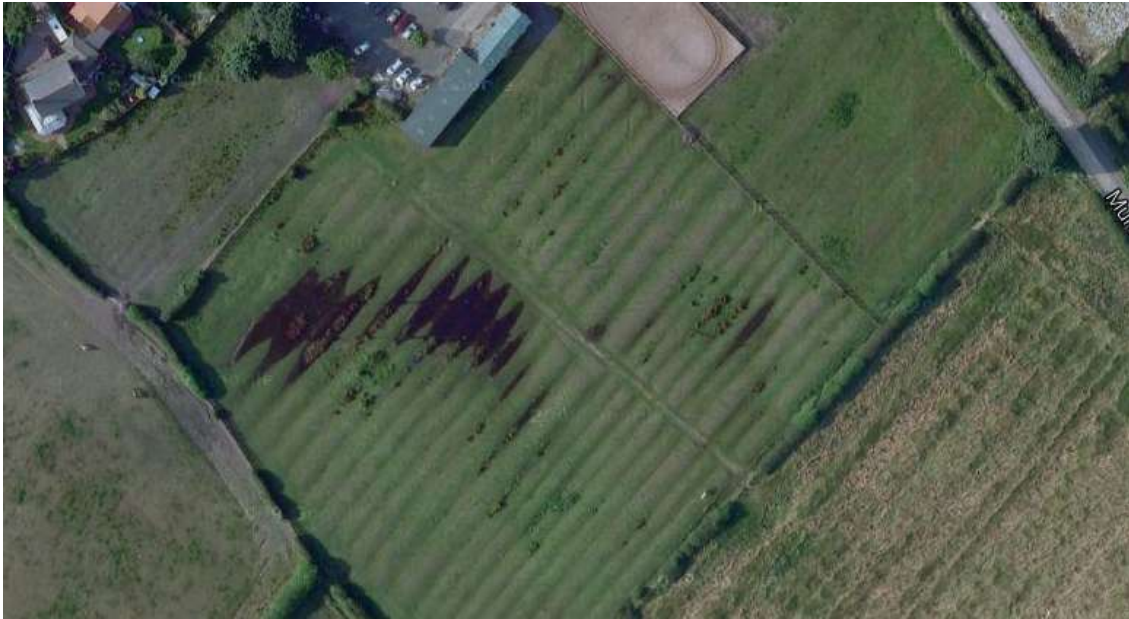
Figure 01: Evidence of ridge and furrow, south of Murton Village (map from Google Maps)

2.1.2 The HER notes that ridge and furrow survives as earthworks in pasture in fields north-west and south-east of Murton (see Figure 01) and on the west side of Murton Lane between the Village and New York there is a small enclosure with earthworks, perhaps ridge and furrow, and the remains of Murton Cottage. Murton Cottage appears on the first edition Ordnance Survey (OS) map (circa 1860s) (see Figure 02) although probably pre-dates it by some time. It does not appear on maps post the mid-1950s.

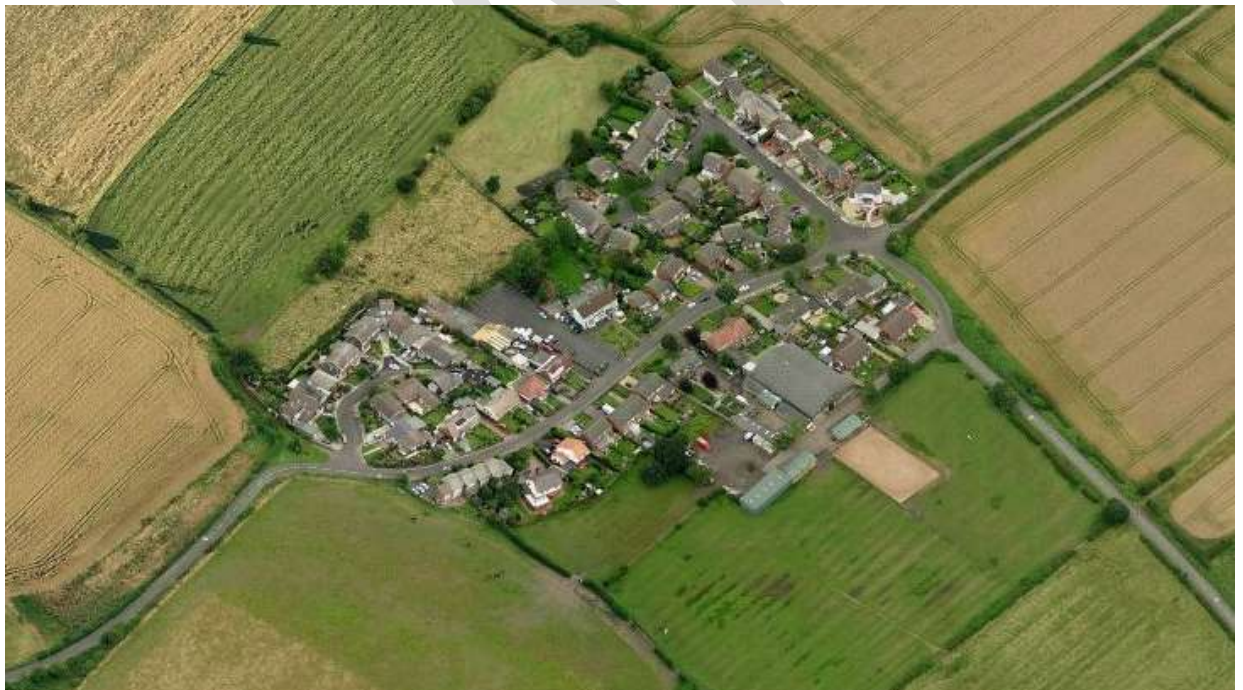
Figure 05: Murton Village in current day (map from Bing Maps)

3.1.5 The Village nor any of its buildings or spaces are designated heritage assets nor are they recognised through the local register. It has little historic fabric and its modern development conceals its traditional layout (see Figure 05). The heritage

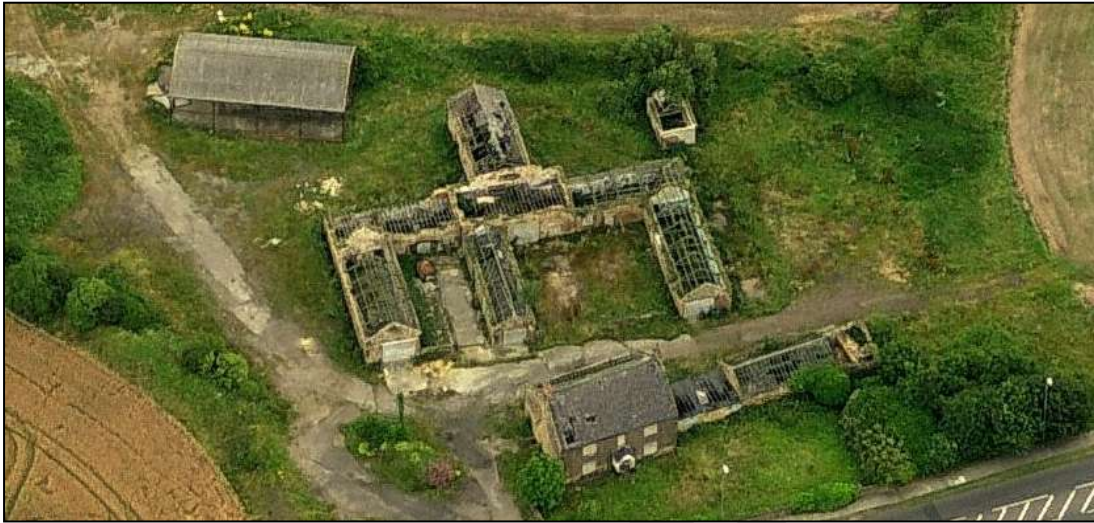
Figure 08: Rake House Farm in disrepair, c.2005 (map from Bing Maps)

4.1.4 In recent decades, Rake House Farm fell into disrepair. This can be seen on the aerial map image in Figure 08. A planning application was approved in 2005 for the conversion of farmhouse and outbuildings to office units, construction of infill office space and demolition of steel barn and stone outbuildings¹². This was a revision of a similar lapsed scheme approved in 2002¹³.

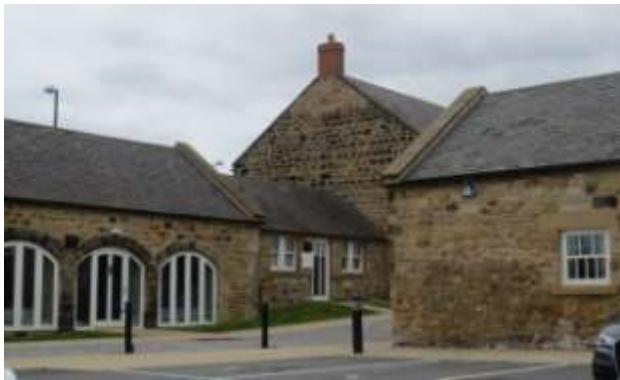
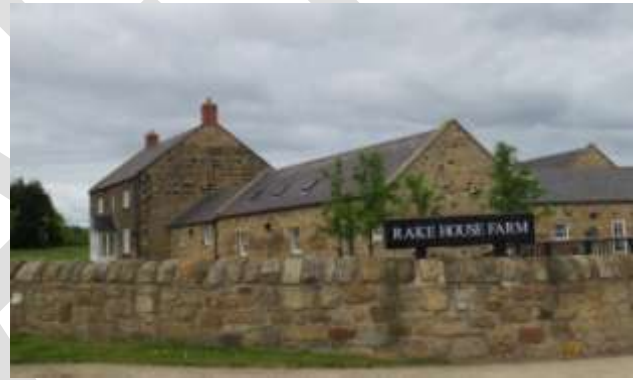
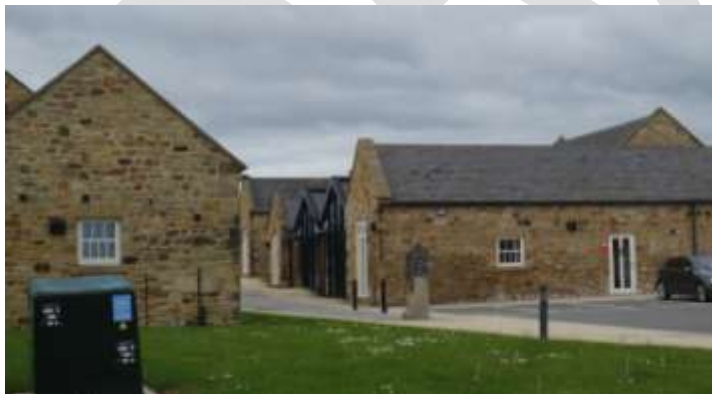
Figure 09: Rake House Farm today, including modern infill, left

4.1.5 Now implemented, the conversion has been of high quality and has certainly saved Rake House Farm from substantial or complete loss (see Figure 09). However, it has had an impact on the significance of the heritage asset. The original building layout has been somewhat compromised by a modern infill in the eastern range of the barn building and its new use of offices lessens its historic value.

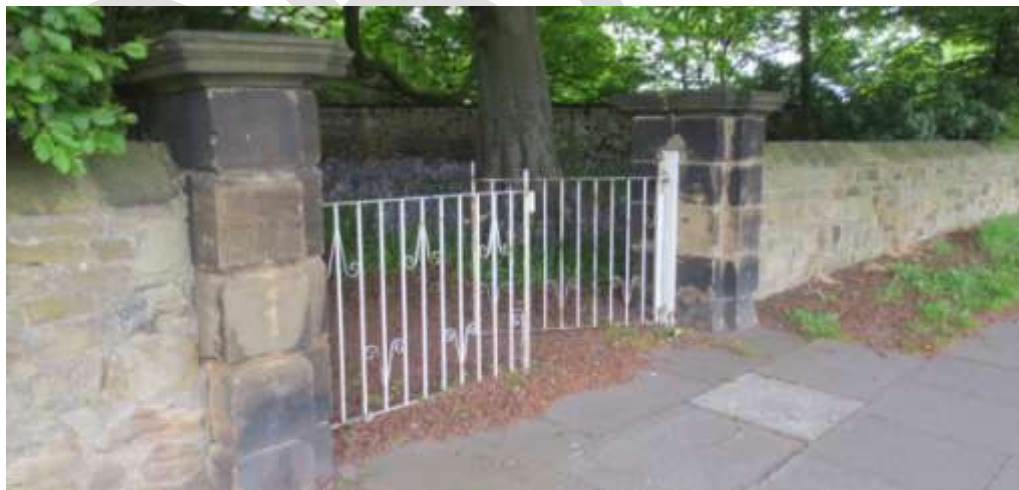
Figure 10: Grade II listed gate piers at Murton Farmhouse

2 gate piers. Tooled rusticated ashlar. Rectangular section with rebated inner corners, cornice and low-sloped coping.¹⁵

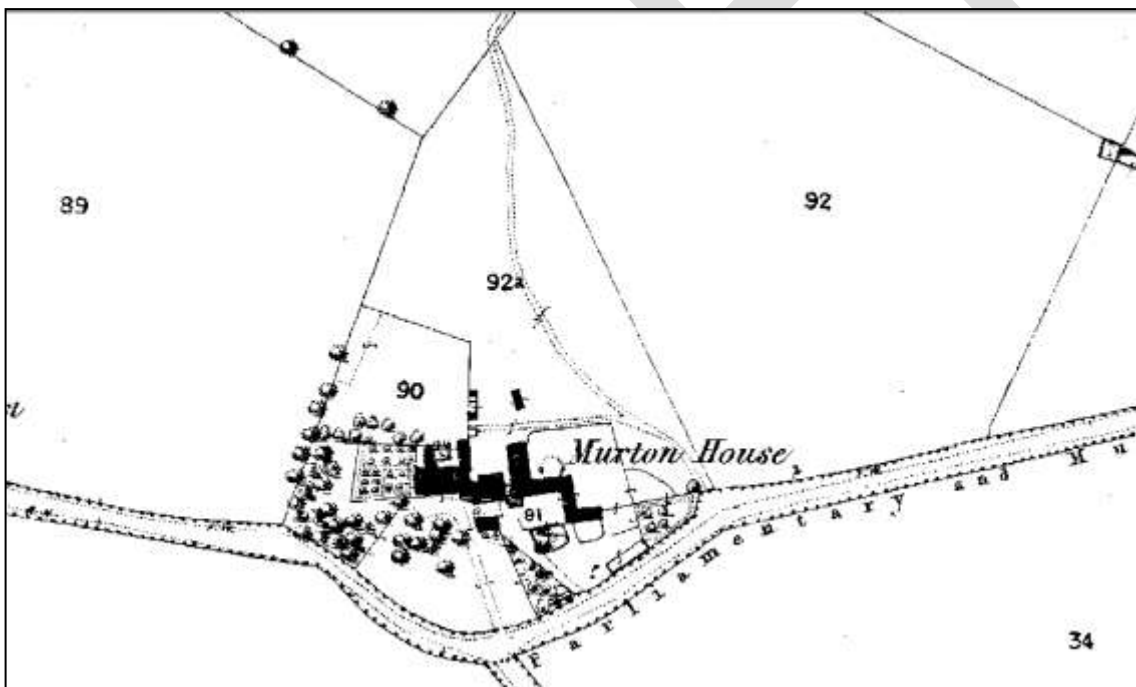
Figure 11: 1st edition OS map showing Murton Farmhouse and original road layout (courtesy of North Tyneside Council)

5.1.4 Early OS maps show the isolated house and farm; they form a sprawling complex with a farmhouse, a large barn with gin-gang and several other buildings (see Figure 11). Surrounding the buildings are heavily treed areas and laid out gardens. Today the buildings are of considerable architectural quality and character, although some are not in good condition. Surrounding building work has been seen, with the loss of a gin-gang and further barn additions.

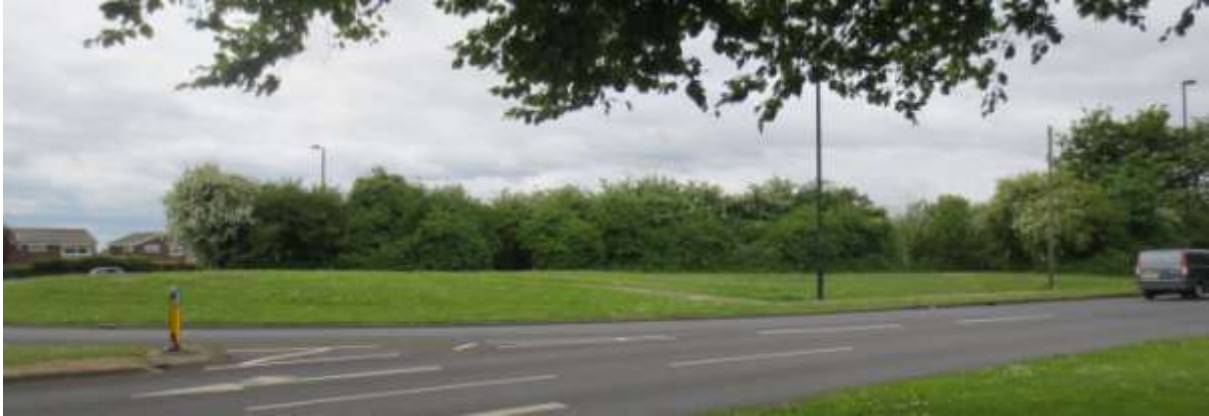
Figure 12: A row of trees by the roundabout marks the former route of the road

5.1.5 Early maps show the plot to be an unusual shape, forming a point in the north and with a pronounced curve along the southern boundary. This curve no longer exists; the road has been regulated and a roundabout introduced, removing some of Murton Farmhouse's original land and rebuilding its boundary in its new location. It is understood from an assessment of map regression that this occurred in the late 1960s or early 1970s. It must have been undertaken with some care as to ensure the retention of the original gate piers, which have since been listed (see Figure 10). A line of trees to the west of the roundabout delineate the original route's course (see Figures 12 and 13).

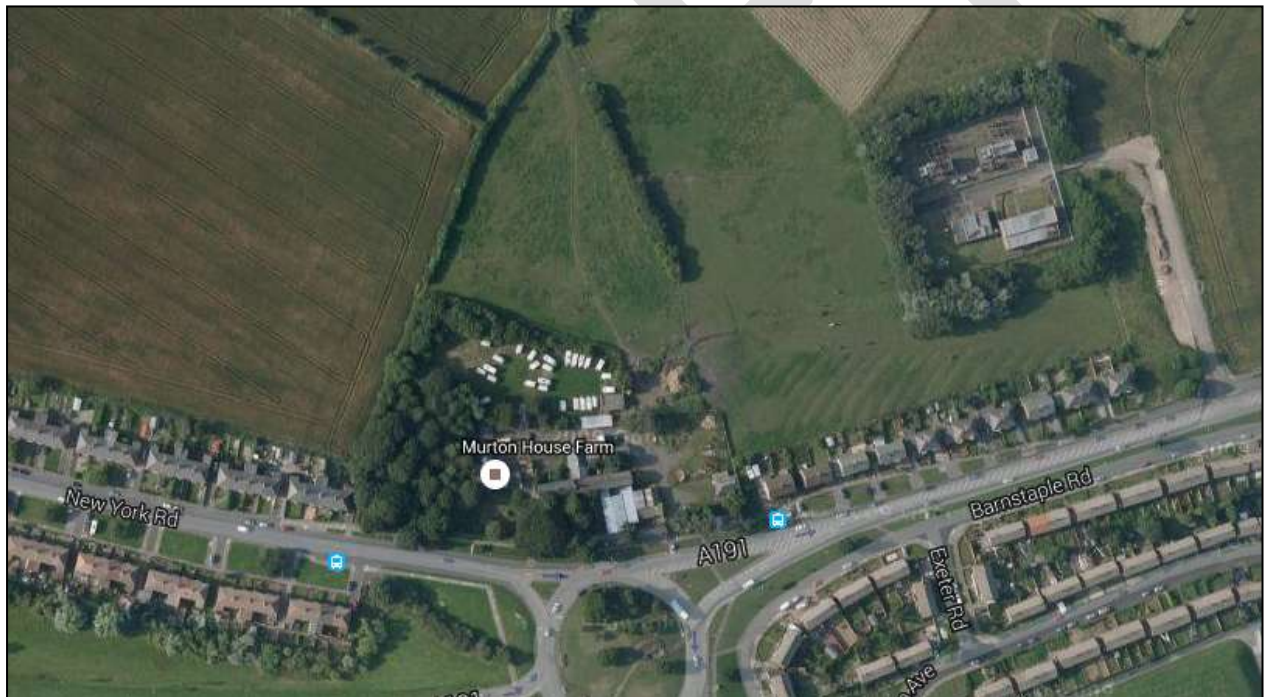
Figure 13: Murton Farmhouse, roundabout and existing field boundary, present day (map from Google Maps)

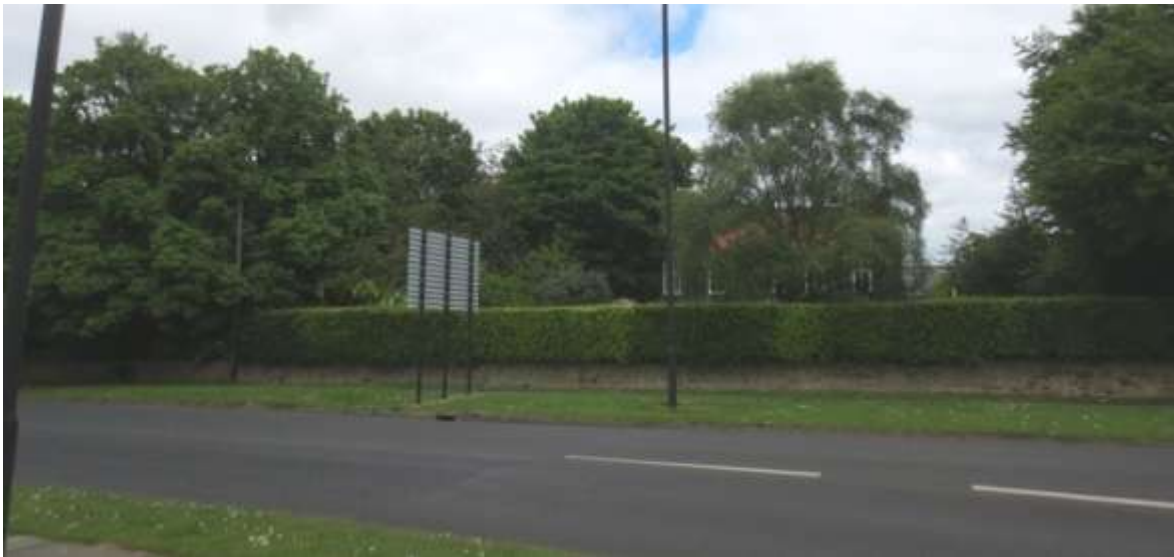
Figure 14: Murton Farmhouse, surrounded by trees

5.1.6 Unusually for farmsteads in this area, Murton Farmhouse's setting is not defined by an open aspect. It is completely surrounded by mature trees (poplar, ash, beech and sycamore) that work to prevent it being part of a wider setting and conceals it from its surroundings (see Figure 14). Many of these trees are protected through Tree Preservation Orders. The first edition OS map tells us that this has been Murton Farmhouse's setting for at least some 150 years. The unusual pointed

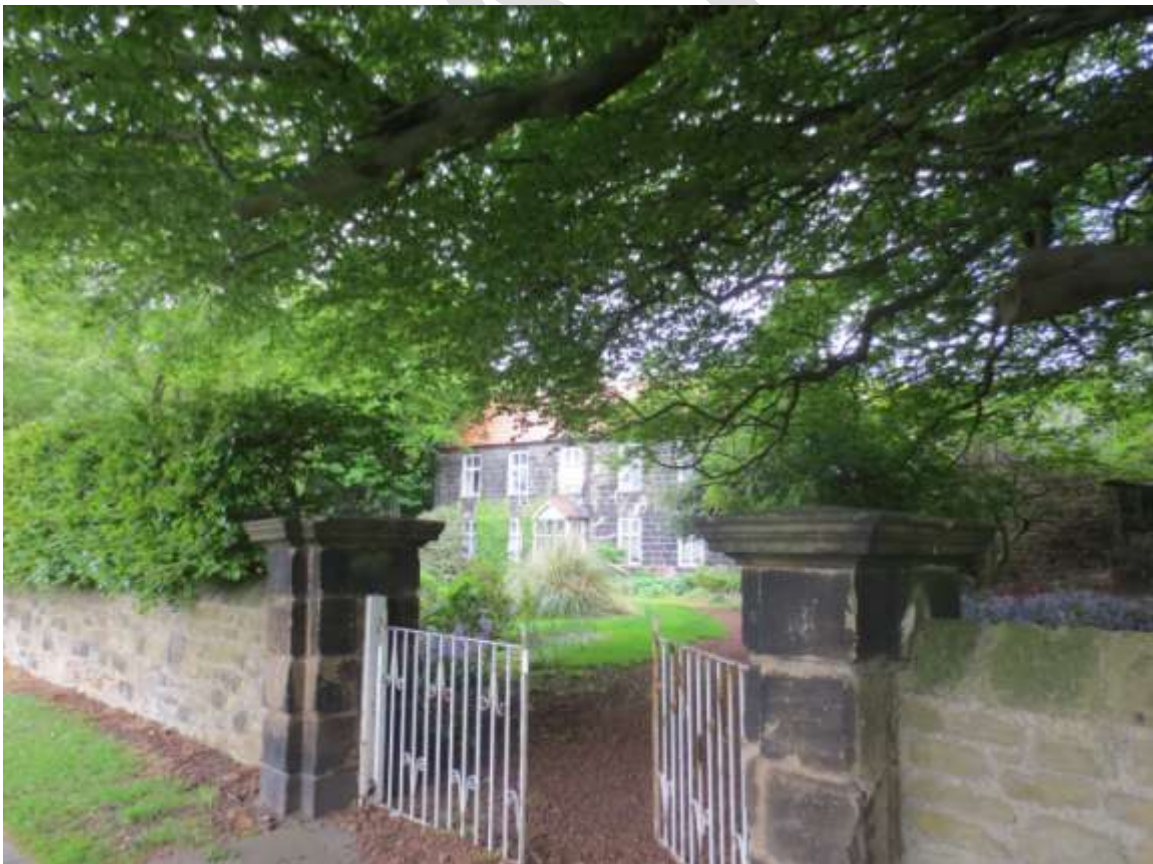
Figure 15: Murton Farmhouse, with gate piers

Farmhouse; mid C18 with later additions. Coursed squared sandstone; pantiled roof with flat stone gable coping on curved kneelers; brick chimneys. Double span. 2 storeys, 5 windows. Central half-glazed door in late C19 porch; flat stone lintels to wood cross windows with early C20 glazing. Ground floor left return has round-headed window in stone surround with impost blocks. Steeply-pitched roof with swept eaves and end chimneys, the left rear one on ashlar base.¹⁴

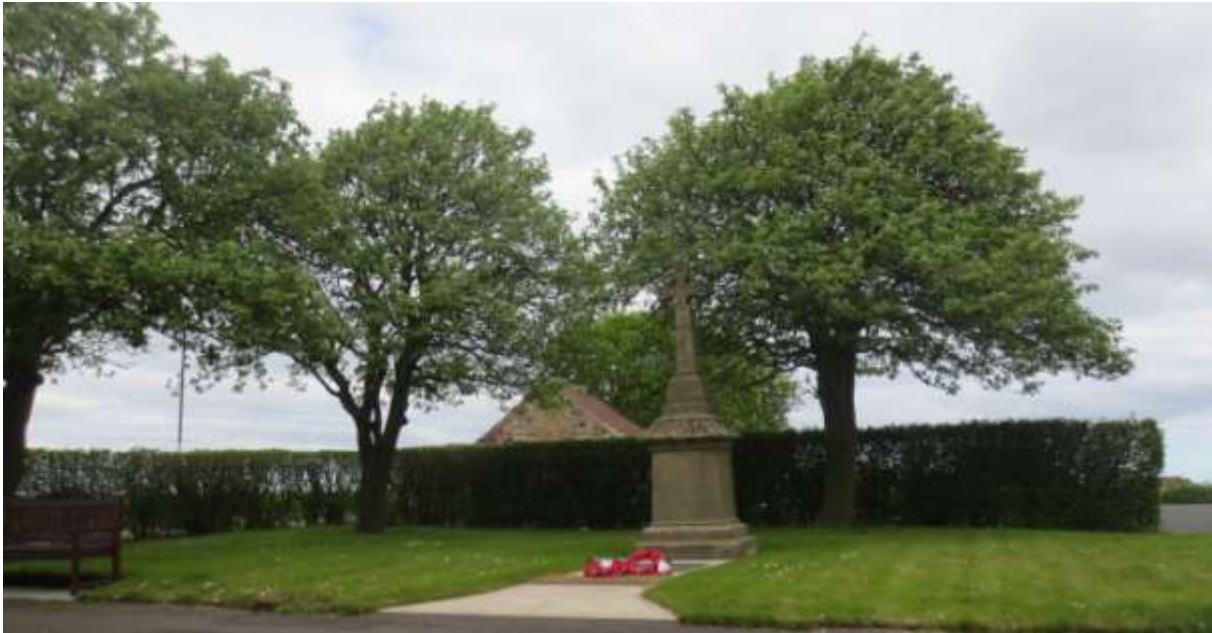
Figure 16: New York War Memorial and setting

6.1.3 The Memorial is good-looking structure and sits within an area of grass surrounded by a hedgerow and mature trees that serve to attractively frame it (see Figure 16). It is of high evidential, historical and communal value in both a local and national context, as well as being a well executed war memorial in the form of a Celtic Wheel Cross; it is thus high in heritage significance.

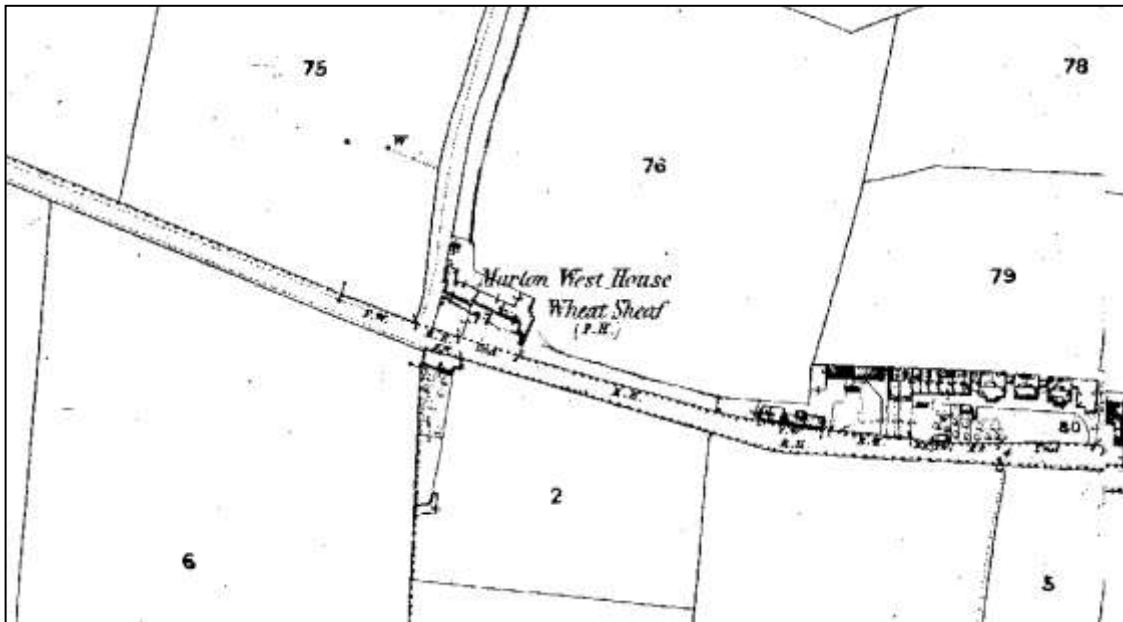
Figure 17: 1st edition OS map (courtesy of North Tyneside Council)

7.1.2 The Pub is illustrated on the first edition OS map (see Figure 17) but there has potentially been a pub on the site for much longer than this.

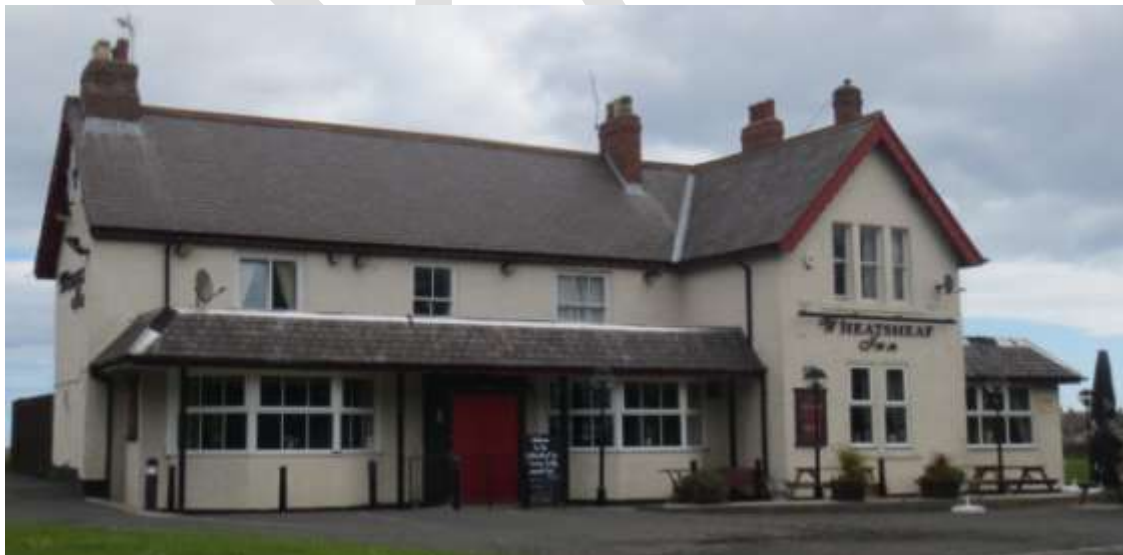
Figure 18: The Wheatsheaf Public House

7.1.4 The building is of reasonable attractiveness and has some retention of historic fabric such as windows of different eras, slate roof with terracotta ridge and chimneys of good intactness, but its heritage significance is harmed by its layers of extensions and alternations (see Figure 18). There is a stone and brick barn building within the Pub's car park on Murton Lane that appears to possibly be a remnant of Murton West House (see Figure 19), which is no longer extant on the third edition OS map so was lost in the early 20th Century . The barn (also not designated), of rubble sandstone, red brick and terracotta tile roof, is a characterful building although not of particular architectural quality.

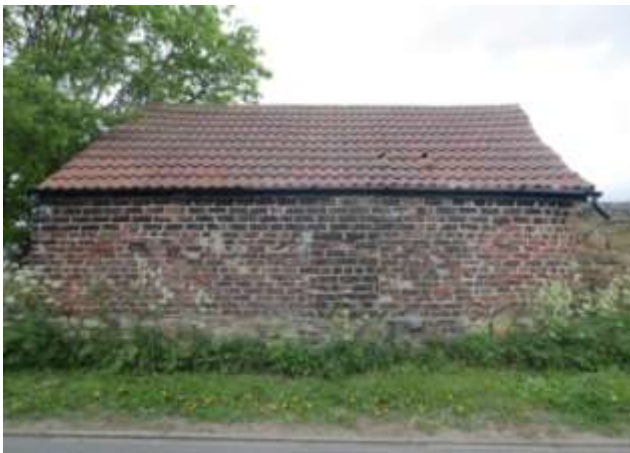
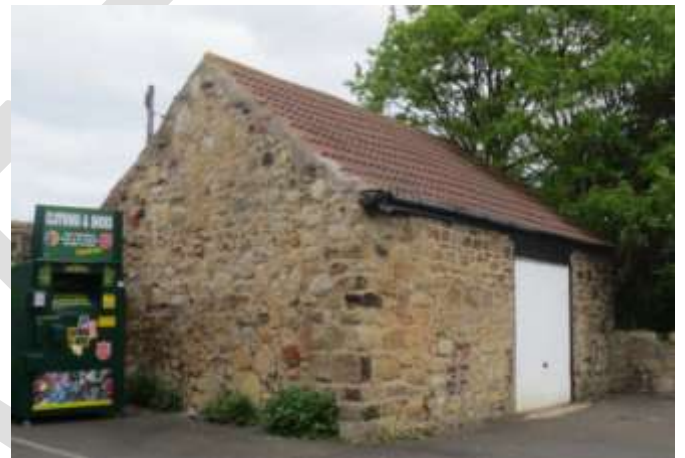
Figure 19: Stone and brick barn

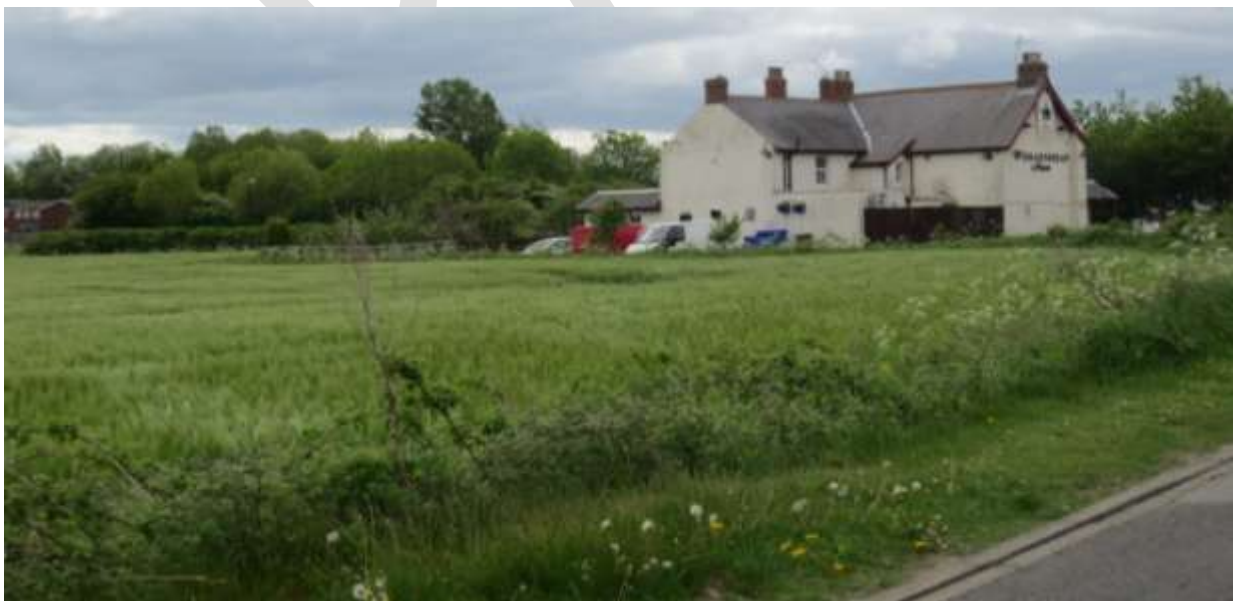
Figure 20: The Wheatsheaf Public House from the north

7.1.5 The Wheatsheaf's reasonably isolated setting affords it some charm and does contribute to a character that many people will relate to the Pub (see Figure 20). However, the undeveloped surroundings have no connection to the function of the Pub or add to its heritage importance. The Pub will have been used by several generations and is of some communal and historical value.

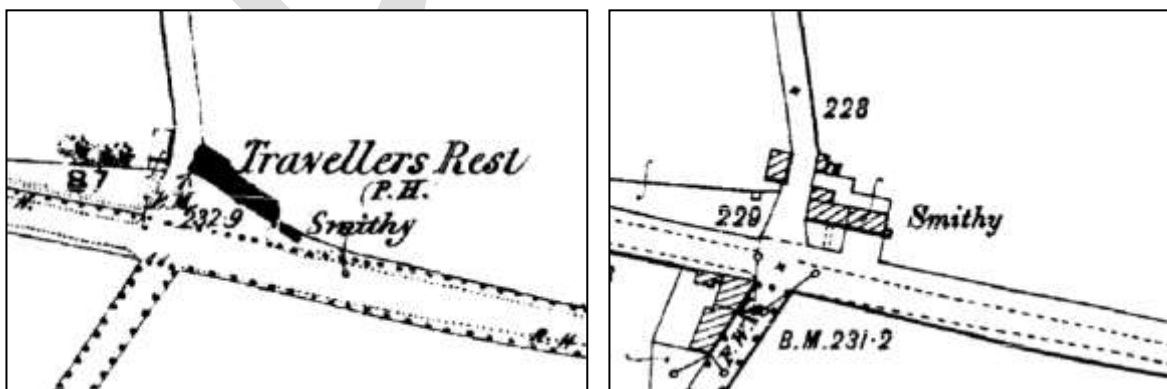
Figure 21: 1st and 2nd edition OS maps, showing a new Smithy on the site of an earlier one (courtesy of North Tyneside Council)

8.1.2 A Smithy can be seen on the first edition OS map, and appears to have been replaced in the second edition OS map with a replacement building that has the same footprint as today (see Figure 21). The Forge can therefore be dated to the late 19th Century but would appear to have an earlier history on the site.

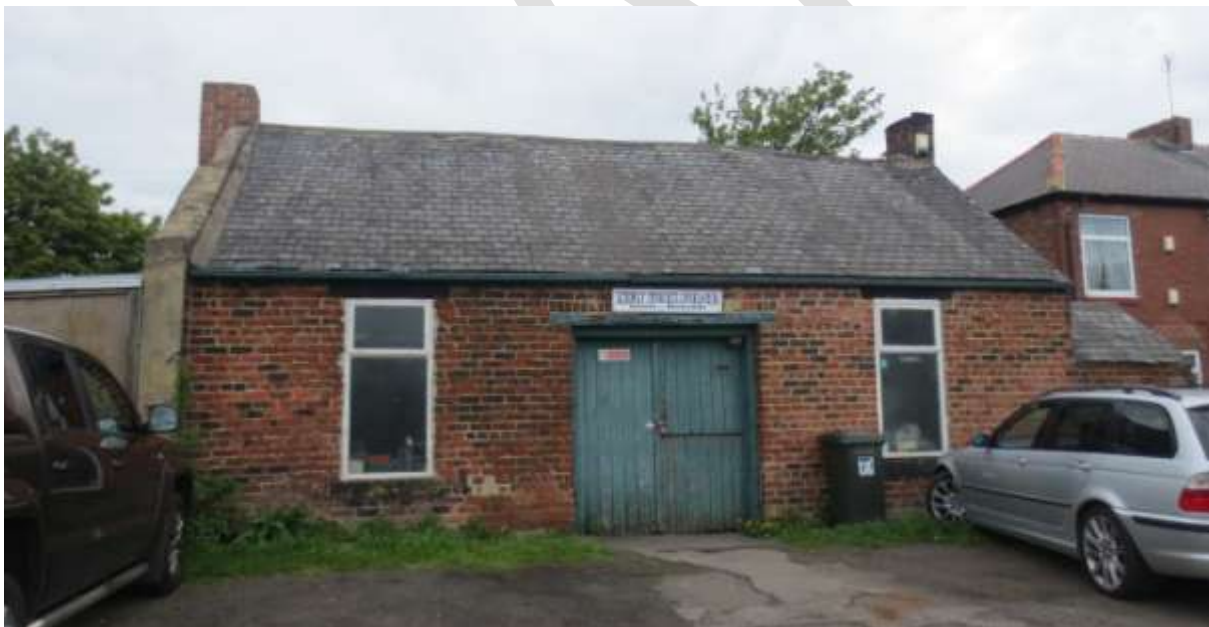
Figure 22: New York Forge

8.1.4 The HER entry suggests this is a building of some interest. Although not a building high in external architectural quality, it has some attraction in its character and charm in its small-scale (see Figure 22). Further studies would be required to
