## North Tyneside Council

### Asbestos Survey Report 22/07/2013 Management Survey

000047091283  
Monkseaton Middle  
Vernon Drive  
Monkseaton  
Tyne and Wear  
NE25 9AQ

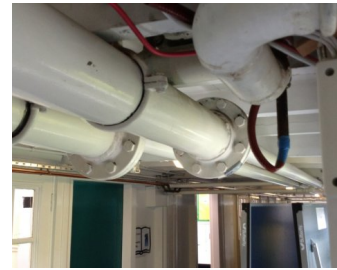
Item Photography

Room/location Reference:	Area 17
Room/location Description:	Corridors
Area/floor Reference:	Ground Floor
Area/floor Description:	
Accessibility:	Accessible
Total ACMs:	1
Total NoACMs:	0

Product Type (a)	N/A
Extent of Damage (b)	N/A
Surface Treatment (c)	N/A
Asbestos Fibre (d)	N/A
Total (a+b+c+d)	12
Material Risk Assessment	<span style="color: red;">■</span> High

Action/recommendations	Monitor
------------------------	---------

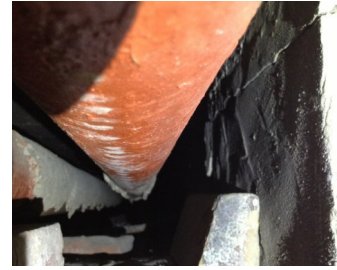
Item Photography

Room/location Reference:	Room 1
Room/location Description:	Boiler Room
Area/floor Reference:	Basement
Area/floor Description:	
Accessibility:	Accessible
Total ACMs:	2
Total NoACMs:	0

Product Type (a)	N/A
Extent of Damage (b)	N/A
Surface Treatment (c)	N/A
Asbestos Fibre (d)	N/A
Total (a+b+c+d)	12
Material Risk Assessment	<span style="color: red;">■</span> High

Action/recommendations	Further Investigation Required
------------------------	--------------------------------

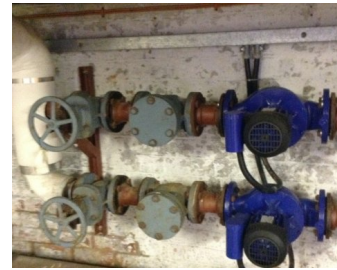
Item Photography

Product Type (a)	1
Extent of Damage (b)	0
Surface Treatment (c)	0
Asbestos Fibre (d)	1
Total (a+b+c+d)	02
Material Risk Assessment	<span style="color: yellow;">■</span> Very Low

Action/recommendations	Monitor
------------------------	---------

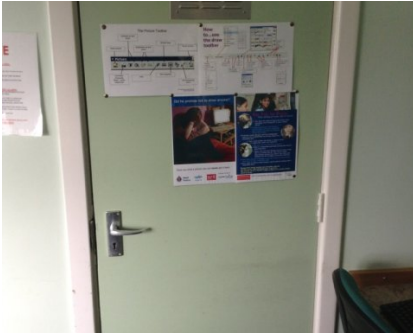
Room/location Reference:	Room 15
Room/location Description:	IT Store
Area/floor Reference:	Ground Floor
Area/floor Description:	
Accessibility:	Inaccessible
Reason for No Access:	No Keys
Total ACMs:	0
Total NoACMs:	0

No Access into This Room Due to no Key on Site. Key Belongs to IT Support Technician

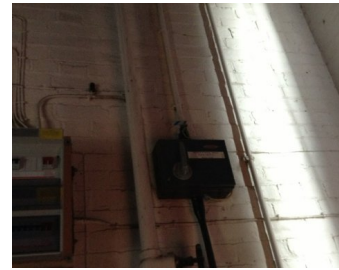
Item Photography

Product Type (a)	N/A
Extent of Damage (b)	N/A
Surface Treatment (c)	N/A
Asbestos Fibre (d)	N/A
Total (a+b+c+d)	12
Material Risk Assessment	<span style="color: red;">■</span> High

Action/recommendations	Further Investigation Required
------------------------	--------------------------------

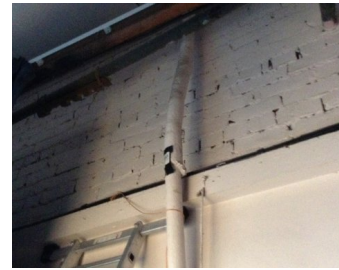
Item Photography

Product Type (a)	1
Extent of Damage (b)	0
Surface Treatment (c)	2
Asbestos Fibre (d)	1
Total (a+b+c+d)	04
Material Risk Assessment	<span style="color: yellow;">■</span> Very Low

Action/recommendations	Monitor
------------------------	---------

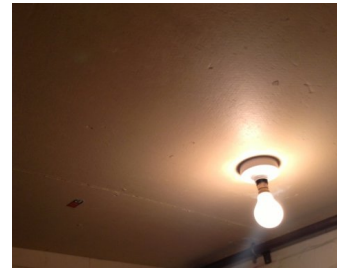
Product Type (a)	2
Extent of Damage (b)	1
Surface Treatment (c)	1
Asbestos Fibre (d)	2
Total (a+b+c+d)	06
Material Risk Assessment	<span style="color: orange;">■</span> Low

Action/recommendations	Encapsulate & Label
------------------------	---------------------

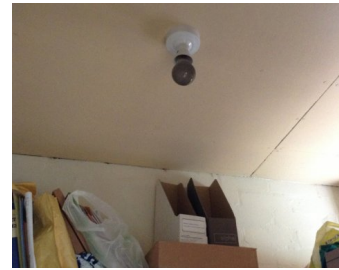
Product Type (a)	2
Extent of Damage (b)	1
Surface Treatment (c)	1
Asbestos Fibre (d)	2
Total (a+b+c+d)	06
Material Risk Assessment	<span style="color: orange;">■</span> Low

Action/recommendations	Encapsulate & Label
------------------------	---------------------

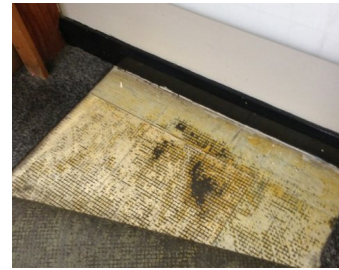
Product Type (a)	1
Extent of Damage (b)	0
Surface Treatment (c)	0
Asbestos Fibre (d)	1
Total (a+b+c+d)	02
Material Risk Assessment	<span style="color: yellow;">■</span> Very Low

Action/recommendations	Monitor
------------------------	---------

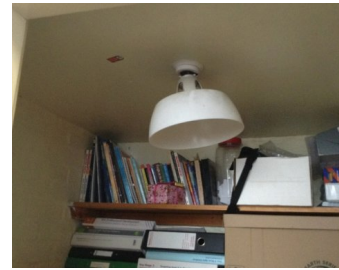
Product Type (a)	2
Extent of Damage (b)	1
Surface Treatment (c)	1
Asbestos Fibre (d)	2
Total (a+b+c+d)	06
Material Risk Assessment	<span style="color: orange;">■</span> Low

Action/recommendations	Encapsulate & Label
------------------------	---------------------

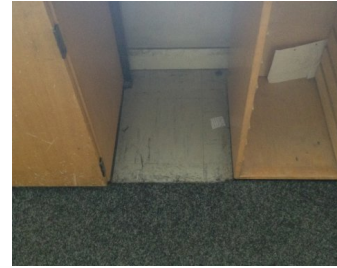
Product Type (a)	1
Extent of Damage (b)	0
Surface Treatment (c)	0
Asbestos Fibre (d)	1
Total (a+b+c+d)	02
Material Risk Assessment	<span style="color: yellow;">■</span> Very Low

Action/recommendations	Monitor
------------------------	---------

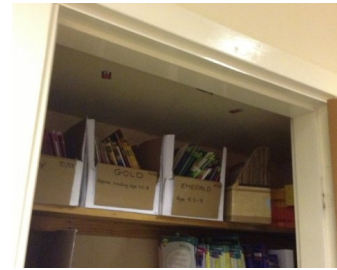
Product Type (a)	2
Extent of Damage (b)	1
Surface Treatment (c)	1
Asbestos Fibre (d)	2
Total (a+b+c+d)	06
Material Risk Assessment	<span style="color: orange;">■</span> Low

Action/recommendations	Encapsulate & Label
------------------------	---------------------

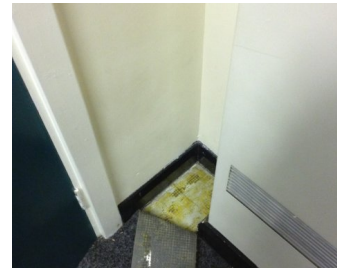
Product Type (a)	1
Extent of Damage (b)	0
Surface Treatment (c)	0
Asbestos Fibre (d)	1
Total (a+b+c+d)	02
Material Risk Assessment	<span style="color: yellow;">■</span> Very Low

Action/recommendations	Monitor
------------------------	---------

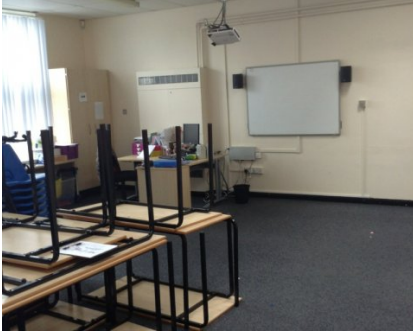
No Access Above Tiles Without Damaging

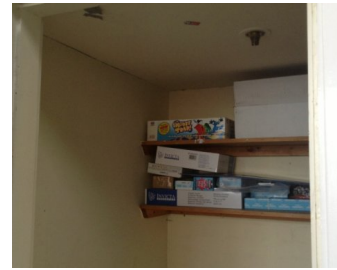
Product Type (a)	2
Extent of Damage (b)	1
Surface Treatment (c)	1
Asbestos Fibre (d)	2
Total (a+b+c+d)	06
Material Risk Assessment	<span style="color: orange;">■</span> Low

Action/recommendations	Encapsulate & Label
------------------------	---------------------

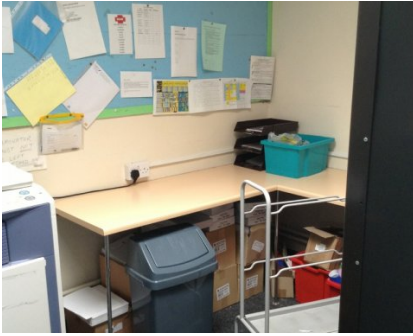
Metal Profile Sheet Roof. Metal Frame Work. Steel Beams. Built in 2004

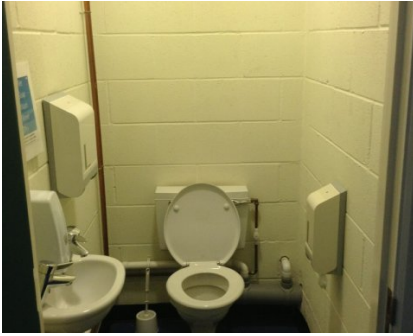
Metal Profile Sheet Roof. Metal Frame Work. Steel Beams. MMMF Insulation to Pipe Work All Above Suspended Ceiling. Built in 2004

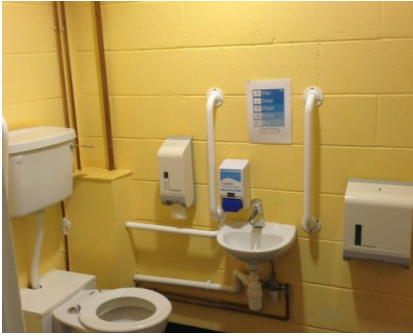
Metal Profile Sheet Roof. Metal Frame Work. Steel Beams

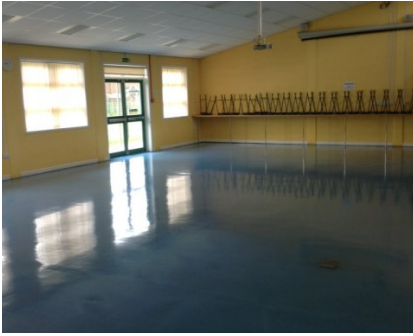
Metal Profile Sheet Roof. Metal Frame Work. Steel Beams

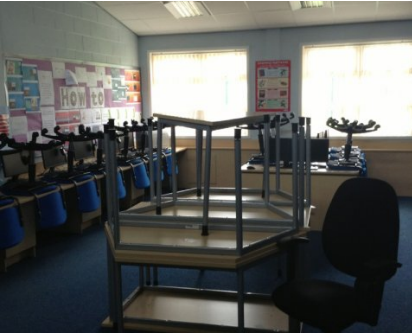
Metal Profile Sheet Roof. Metal Frame Work

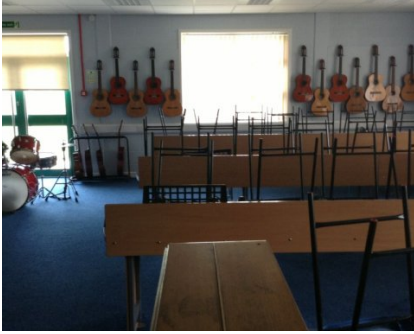
Metal Profile Sheet Roof. Metal Frame Work

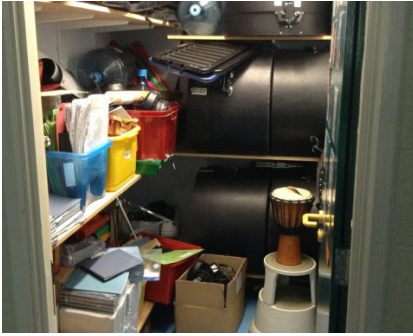
Metal Profile Sheet Roof. Metal Frame Work

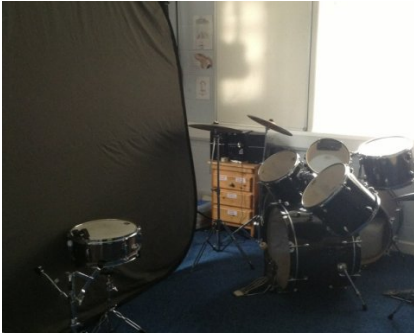
Metal Profile Sheet Roof. Metal Frame Work. MMMF Insulation to Pipe Work

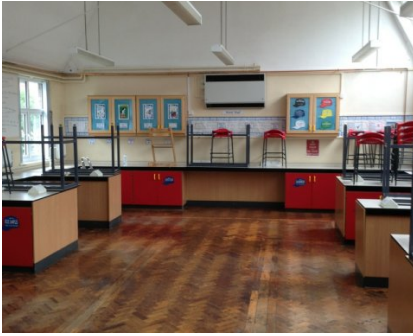
Metal Profile Sheet Roof. Metal Frame Work

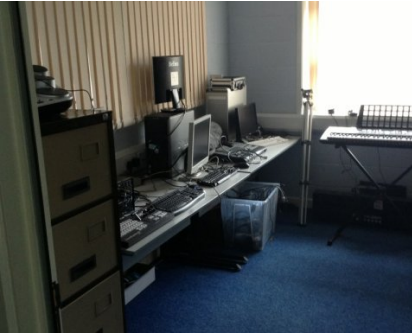
No Access Beneath Floor

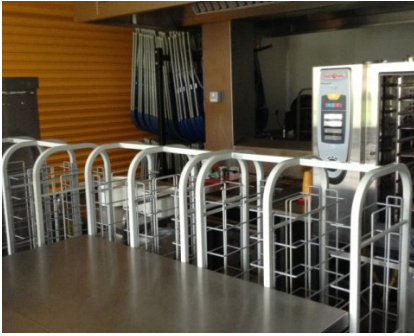
Metal Profile Sheet Roof. Metal Frame Work and Steel Beams Above Suspended Ceiling. Built in 2004

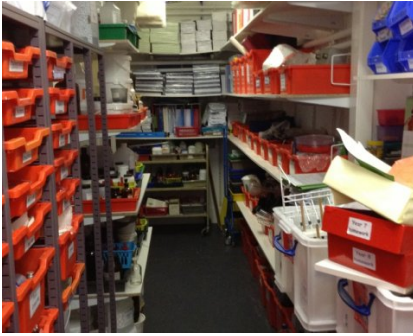
Office and Store Room Inspected
