VERIFICATION REQUIREMENTS FOR GAS PROTECTION SYSTEMS

Technical Guidance for
Developers,
Landowners and
Consultants

Yorkshire and Humberside
Pollution Advisory Council

Version 1.0 – January 2016

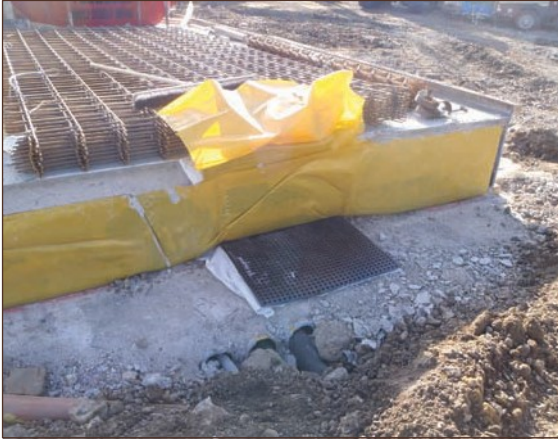
Figure A4.7 Geovent protruding out of the frontage of the unit. Gas membrane along the sides of the slab preventing lateral gas ingress (courtesy Alderburgh Group)

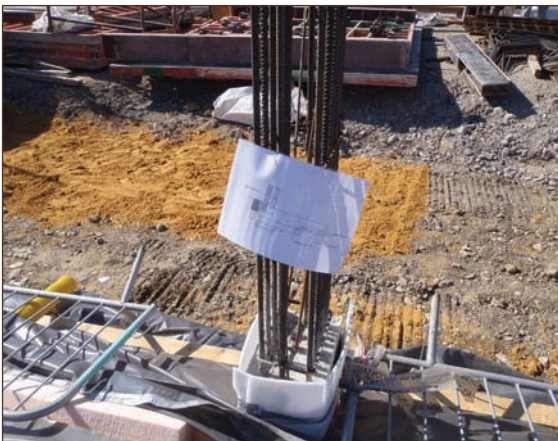
Figure A4.9 On site schematics to aid construction workers build the gas protection system (courtesy Alderburgh Group)

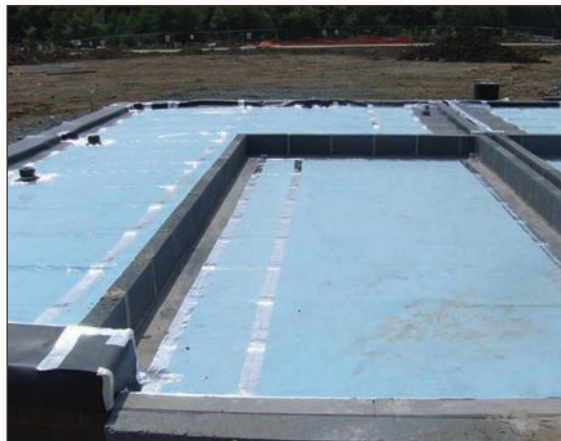
Figure A4.10 Almost complete coverage available for inspection, minimal jointing, service entries suitable distance from walls, light traffic (courtesy Smith Grant)

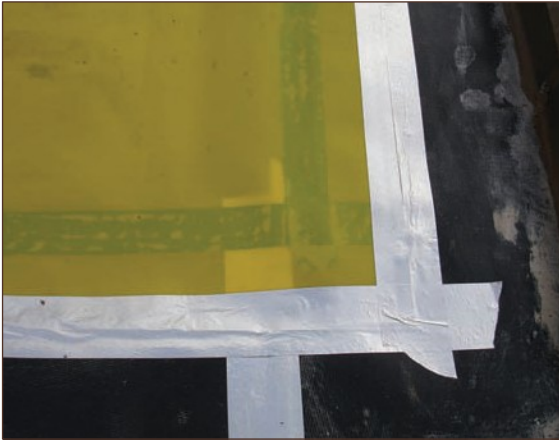
Figure A4.19 Well-constructed joints with gas resistant DPC, lap and double sided butyl joints visible beneath semi-transparent gas membrane, secondary seal with proprietary single sided tape (courtesy Smith Grant)

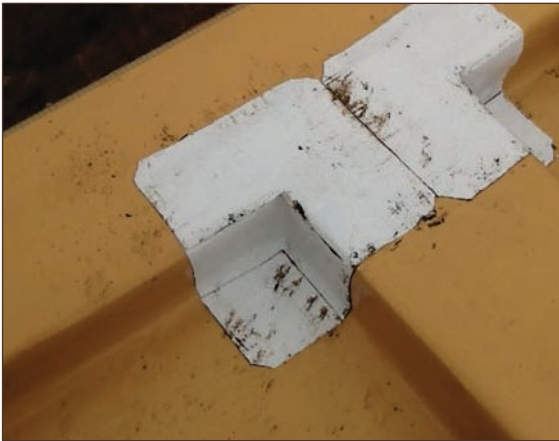
Figure A4.21 Good prefabricated corner detail (courtesy MEC Environmental Ltd)

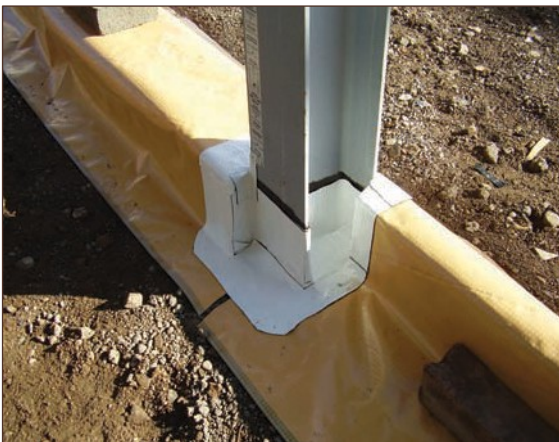
Figure A4.23 Complex column seal (courtesy PAGeotechnical Ltd)

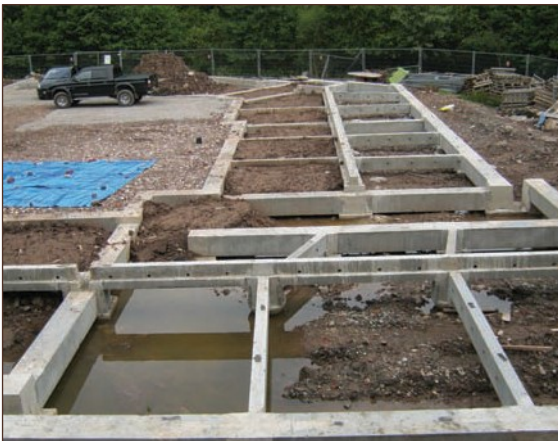
Figure A4.33 *Good ventilation in internal sleeper walls, cast into prefabricated beams (courtesy Smith Grant)*

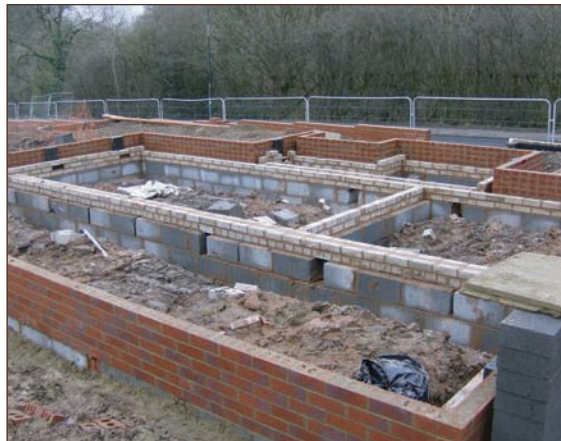
Figure A4.34 *Open void >300mm deep, good ventilation through internal sleeper walls (courtesy Smith Grant)*

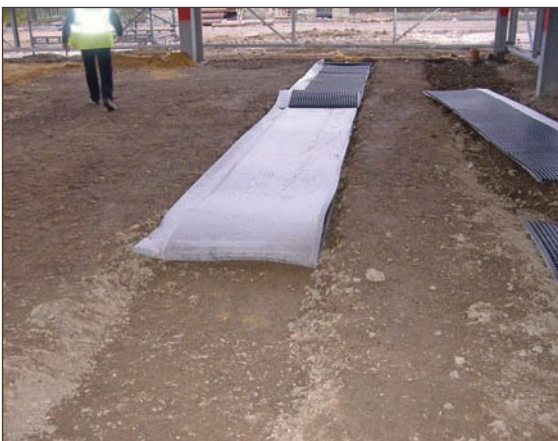
Figure A4.35 *Good installation of passive gas venting trenches and 'egg-crate' (courtesy Card Geotechnics Limited)*

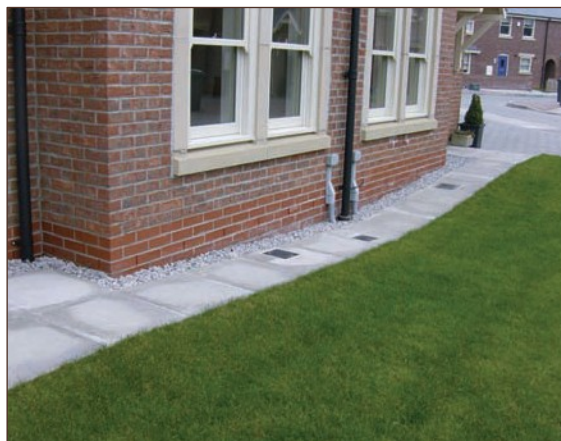
Figure A4.36 *Raised air bricks are preferable due to the reduced potential for blockade but the vent trench specified is provided with clean single sized stone (courtesy Smith Grant)*

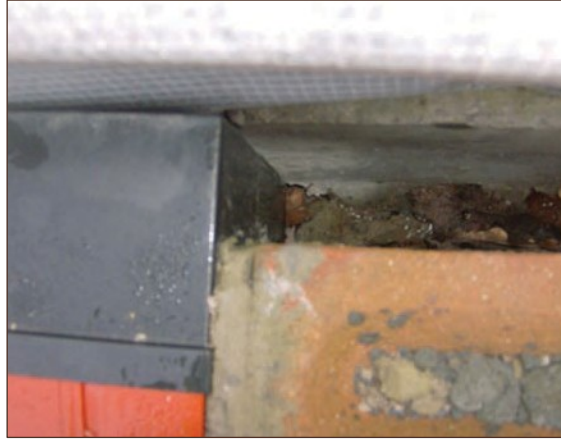
Figure A4.86 Cavity is becoming blocked with detritus. The vent holes in the beam are no longer visible (courtesy Smith Grant)
