# Appendix E Coal Authority Report & Mine Abandonment Plans

**Non-Residential Coal Authority Mining Report**

**MURTON - QUOTE REQUIRED , WHISTLE BAY, MURTON, TYNE & WEAR, NE27 0LR**

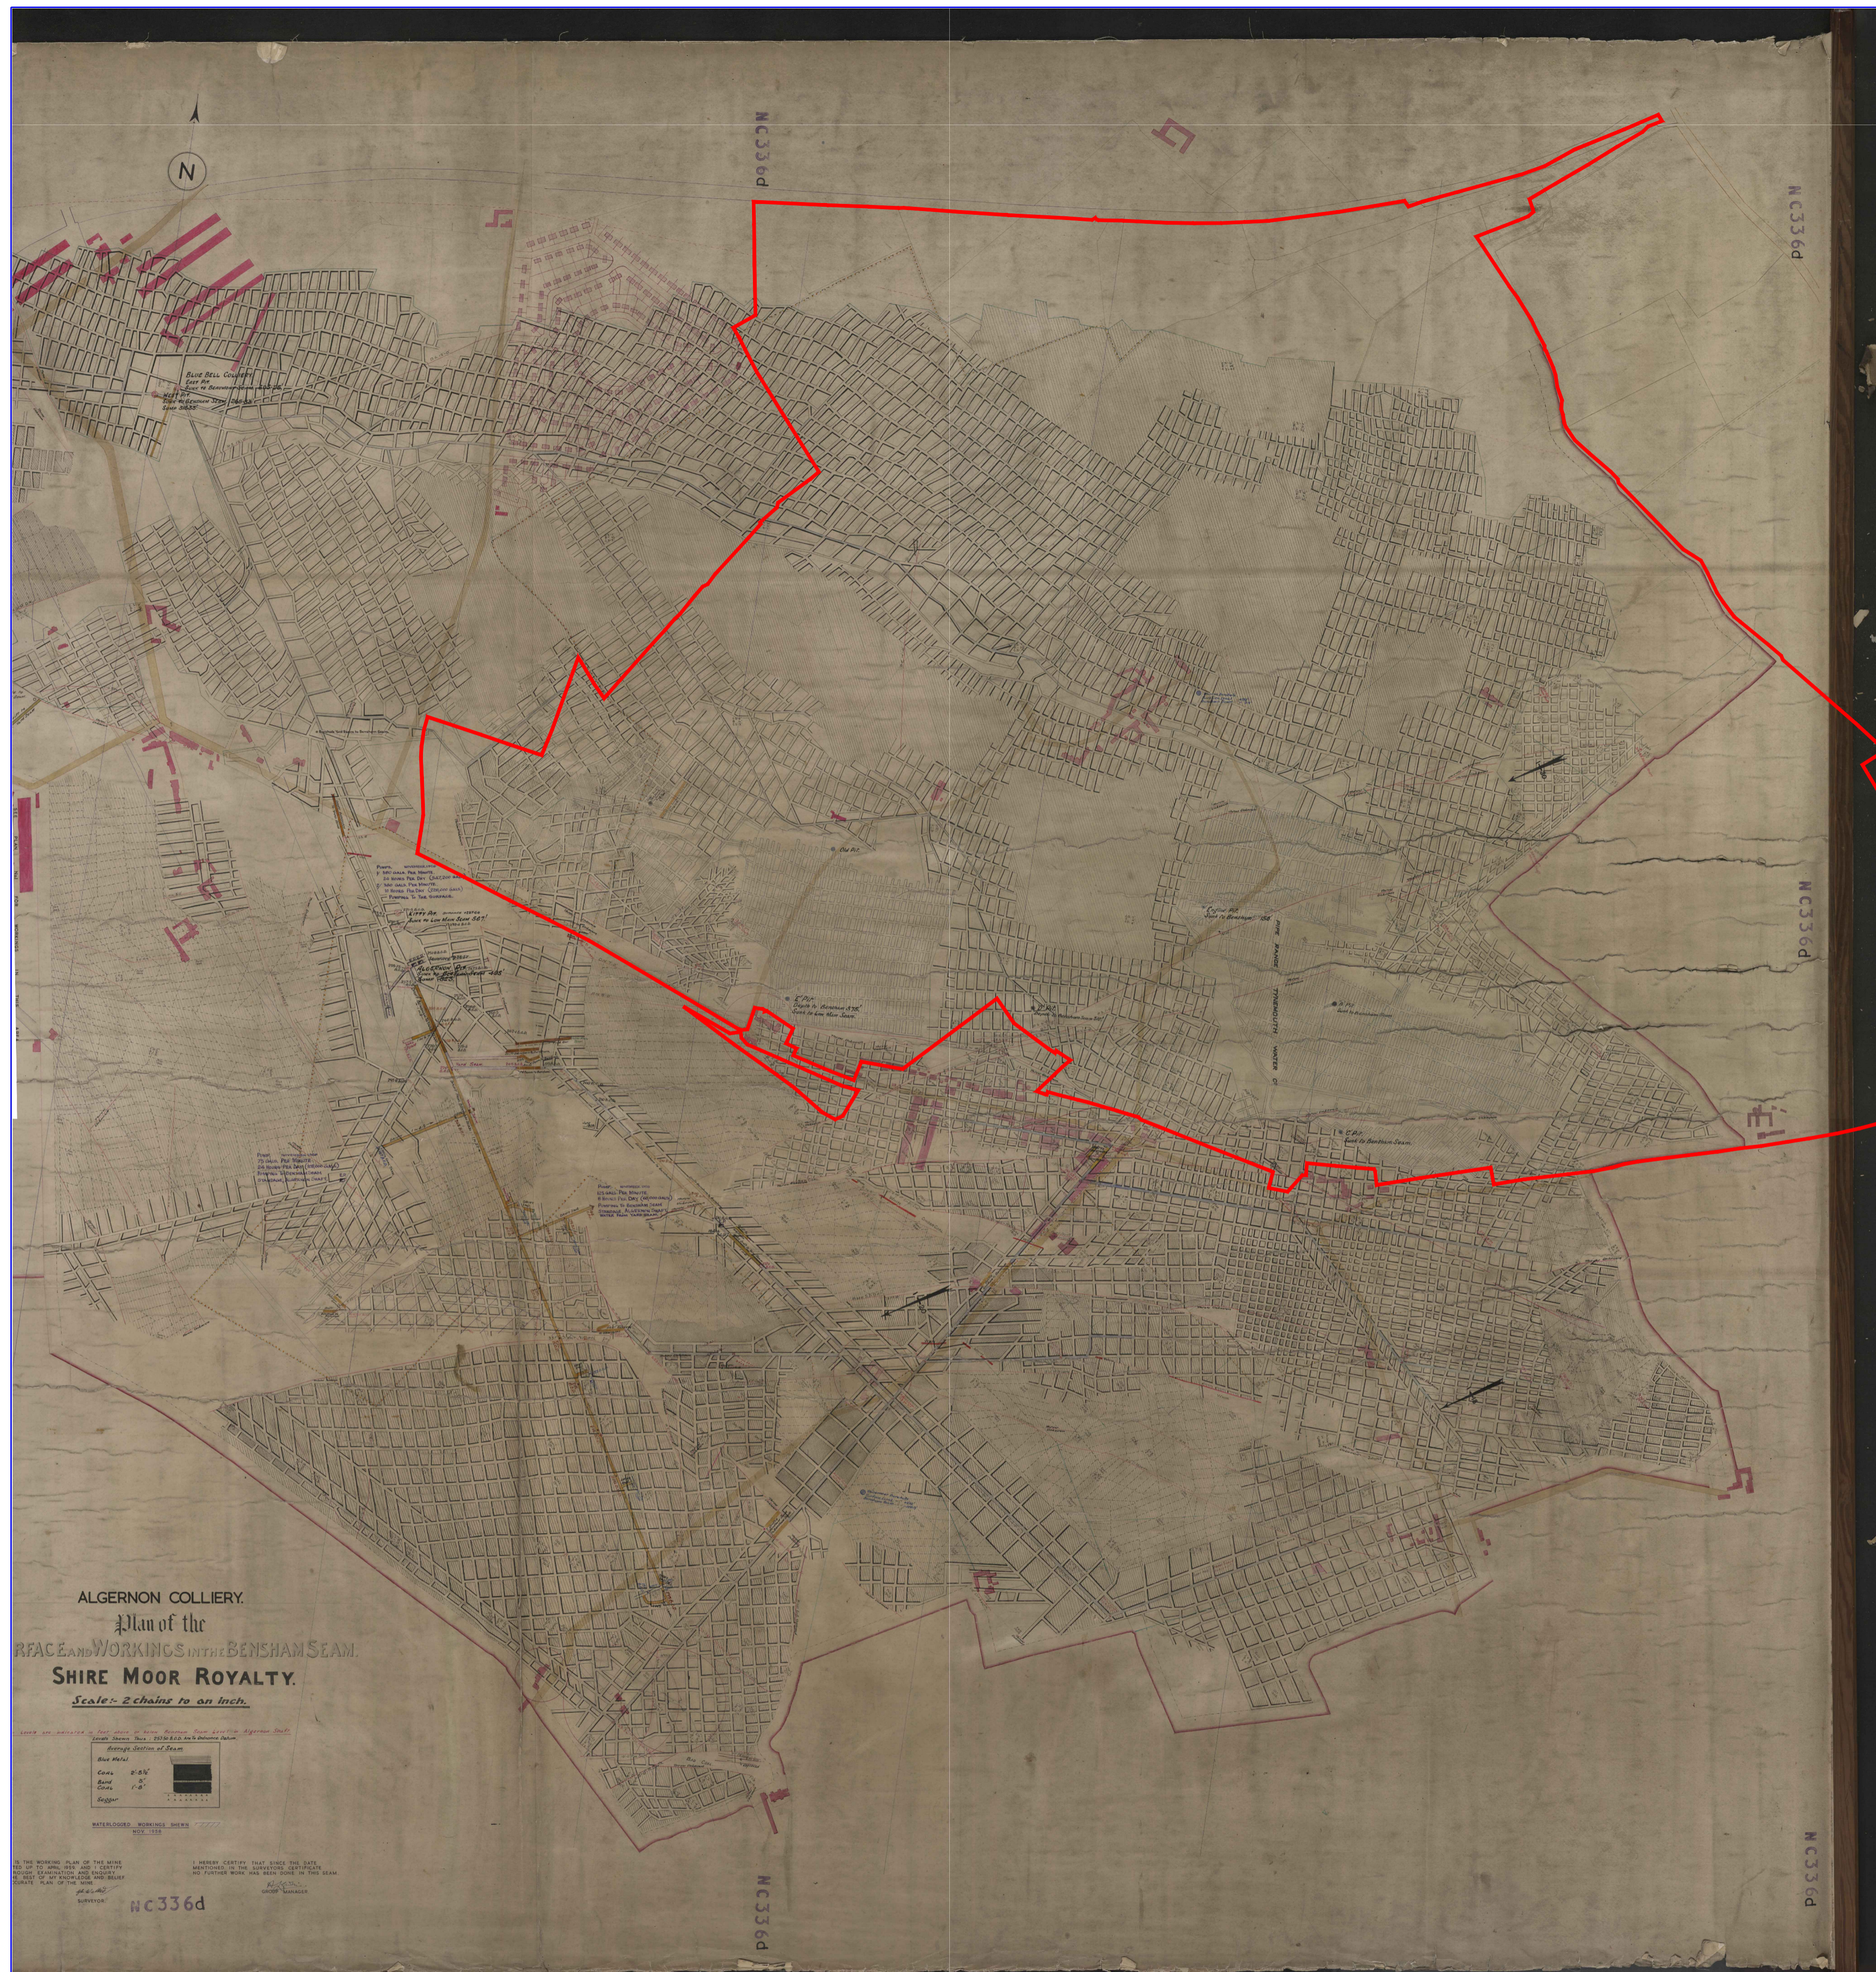
NC336d

**ALGERNON COLLIERY.**  
**Plan of the**  
**FACE AND WORKINGS IN THE BENSHAM SEAM.**  
**SHIRE MOOR ROYALTY.**  
*Scale: 2 chains to an Inch.*

I HEREBY CERTIFY THAT SINCE THE DATE  
 SPECIFIED IN THE ENCLOSURE HERETO  
 NO FURTHER WORK HAS BEEN DONE IN THIS SEAM

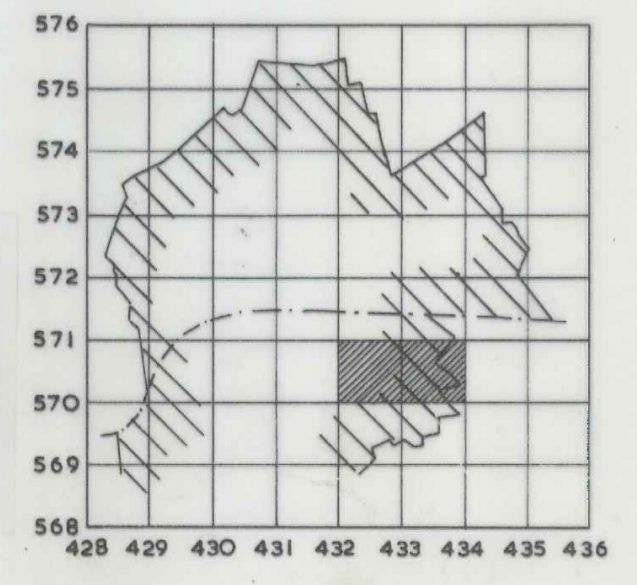
ALGERNON COLLIERY  
YARD SEAM

SECTION OF SEAM —  
SHALE  
COAL 2'-9"  
FIRECLAY

G  
MCR23  
DATE OF CONSTRUCTION 1962

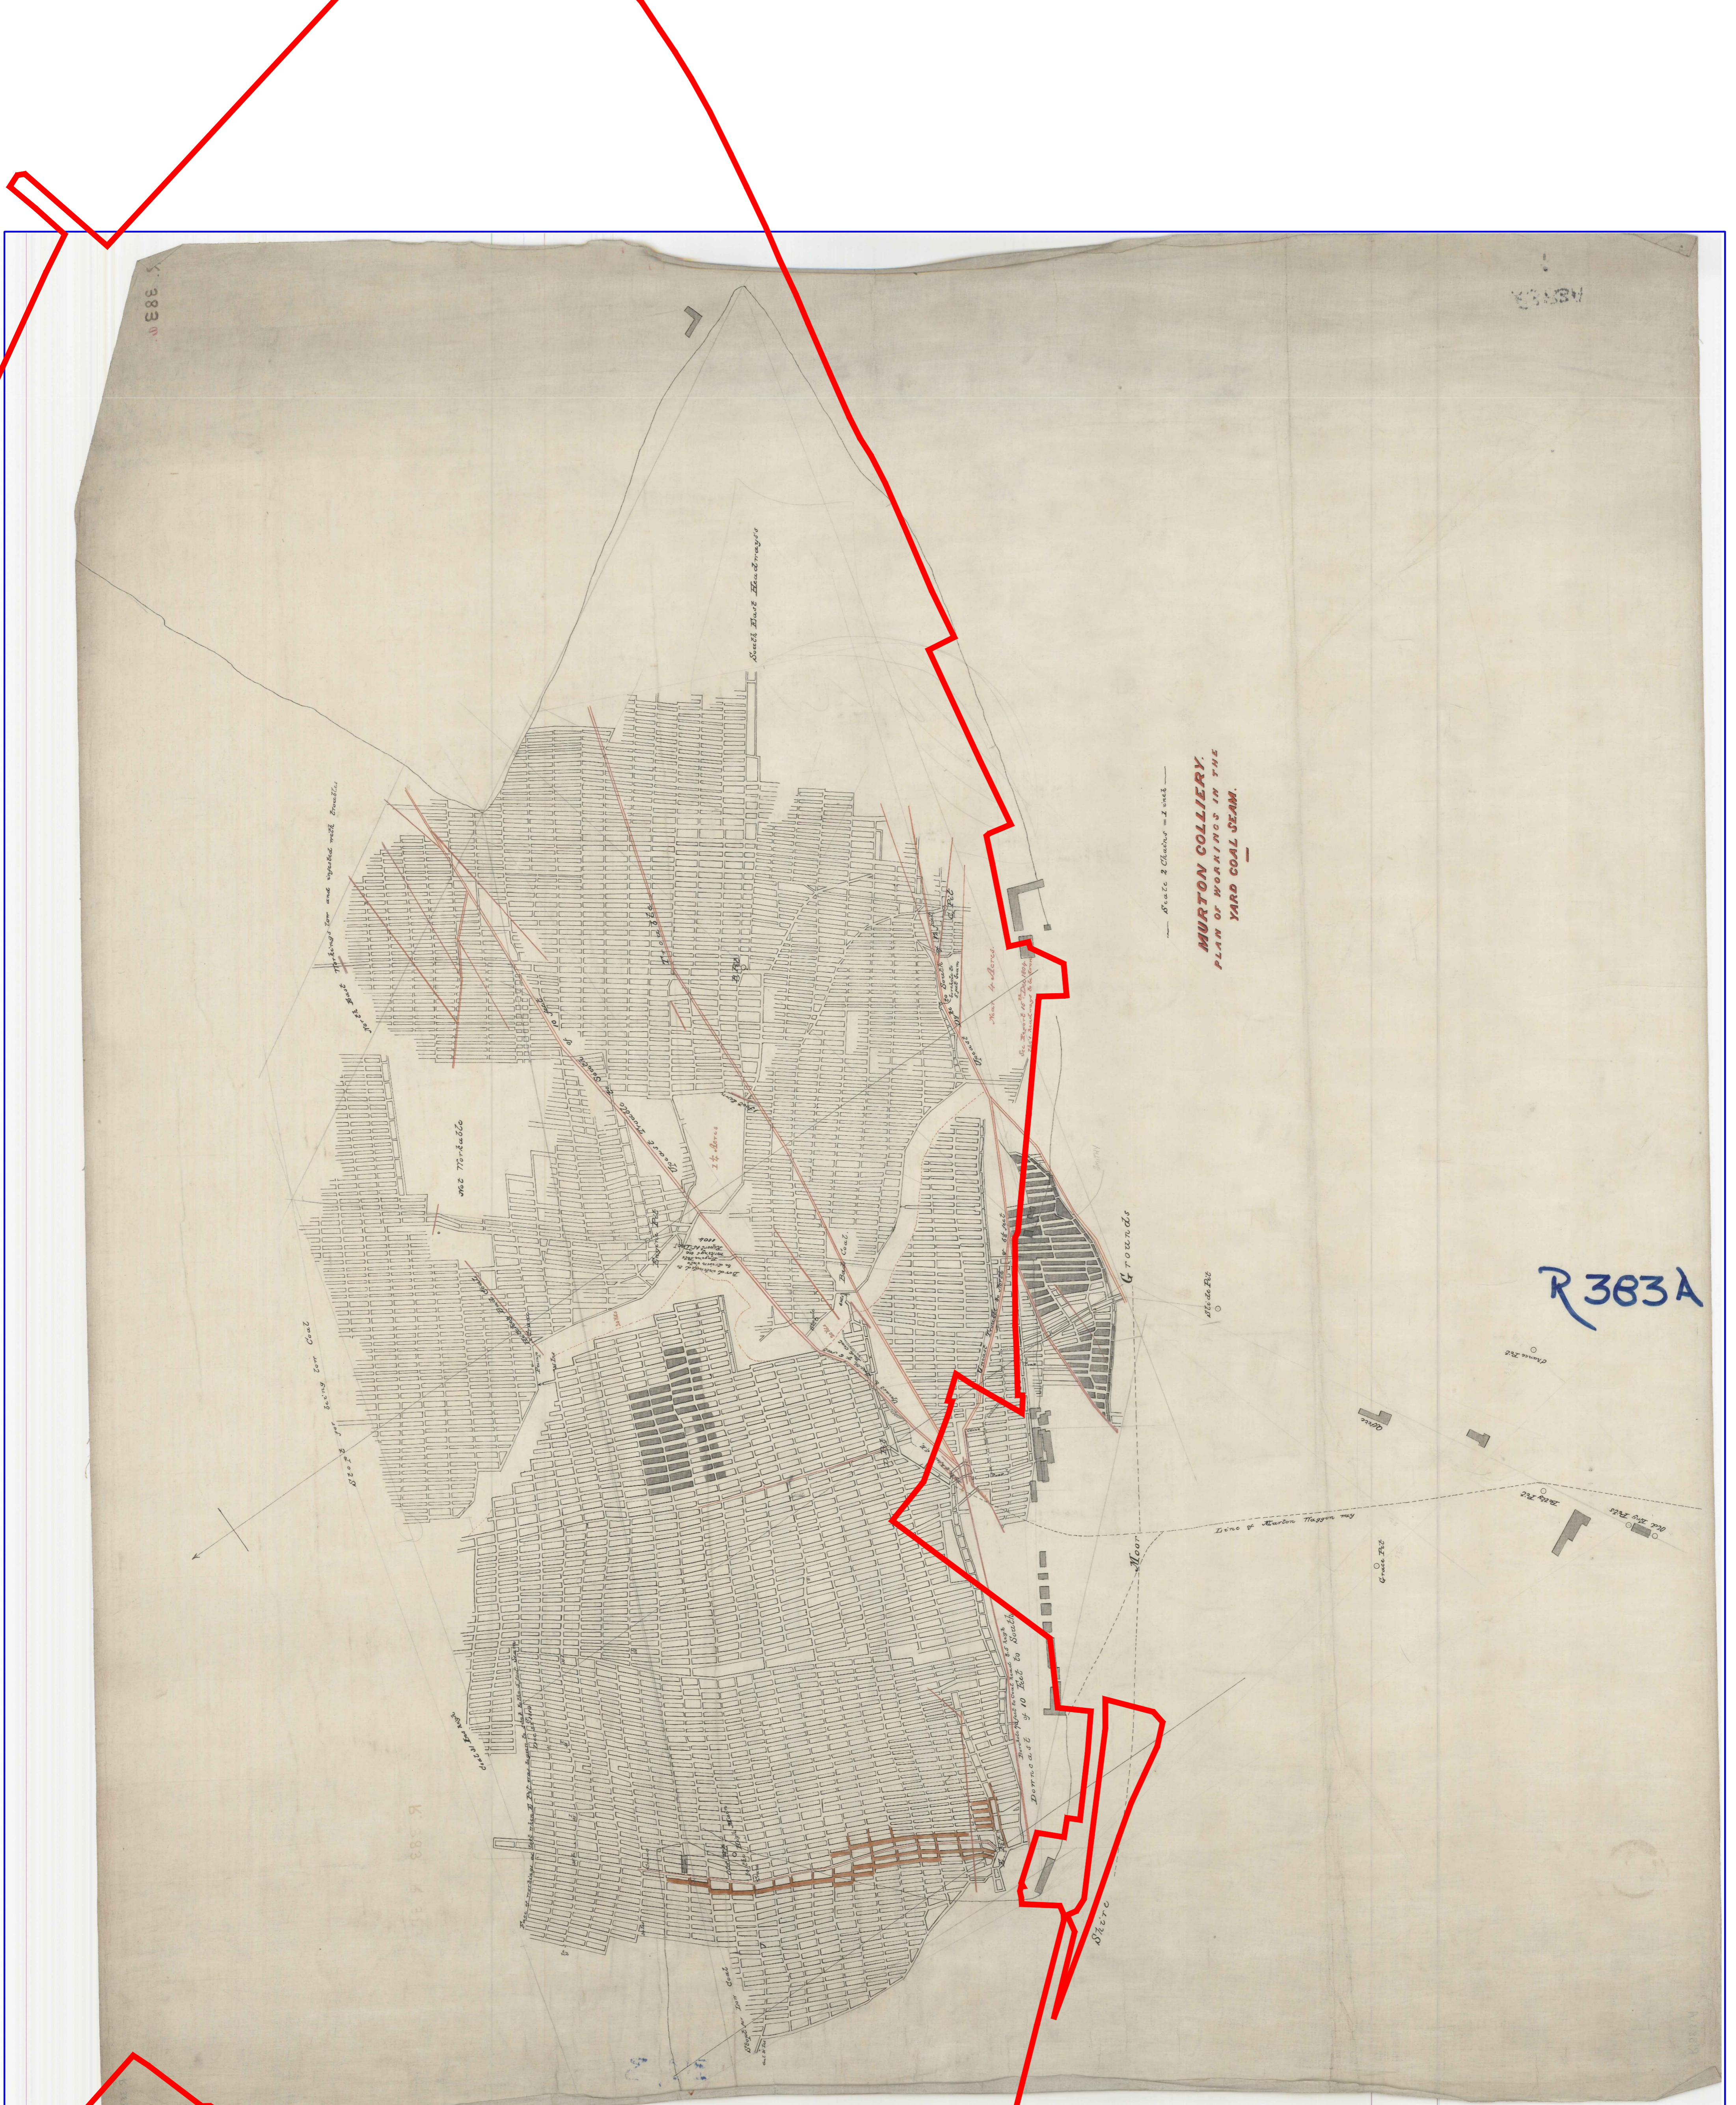
R 383A

**MURTON COLLIERY.**  
PLAN OF WORKINGS IN THE  
YARD COAL SEAM.
