North Tyneside Council

Asbestos Survey Report 27/05/2014-30/05/2014 Management Survey

000047090890
Valley Gardens Middle
Valley Gardens
Whitley Bay
Tyne and Wear
NE25 9AQ

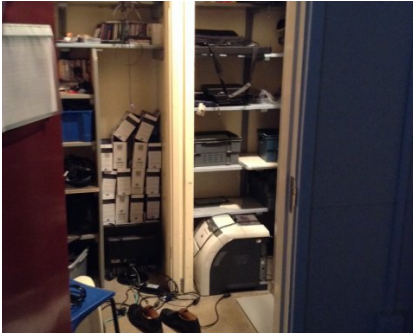
Room/location Reference:	1004B
Room/location Description:	Store Cupboard
Area/floor Reference:	1
Area/floor Description:	First Floor
Accessibility:	Accessible
Total ACMs:	0
Total NoACMs:	0

Computer servers inside.

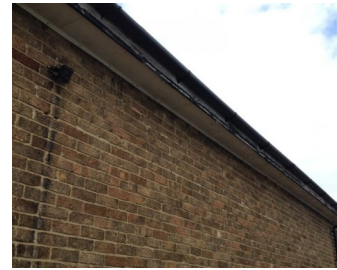
Product Type (a)	1
Extent of Damage (b)	2
Surface Treatment (c)	1
Asbestos Fibre (d)	3
Total (a+b+c+d)	07
Material Risk Assessment	■ Medium

Repair Damaged Area

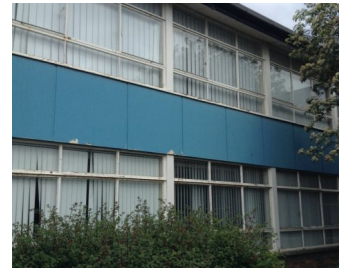
Product Type (a)	1
Extent of Damage (b)	1
Surface Treatment (c)	1
Asbestos Fibre (d)	3
Total (a+b+c+d)	06
Material Risk Assessment	■ Low

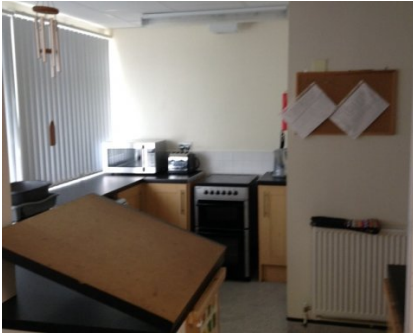
Limited access above MMMF suspended ceiling.

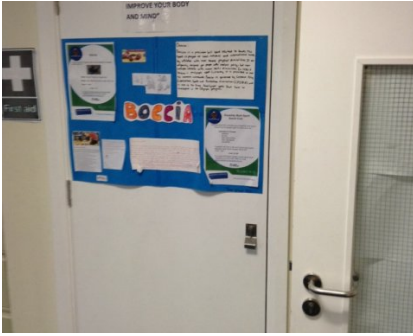
No access within timber boxing.

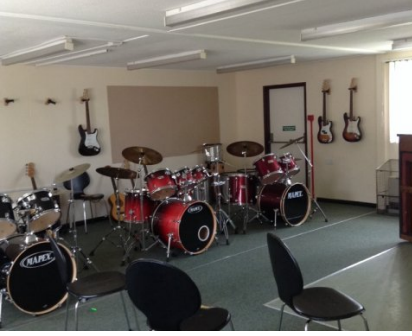
Item ID	017(VRS)
Sample/link ID	S006
Property Name	Valley Gardens Middle
Area/floor	EB
Room/location	EB022
Specific location	Ceiling
Product/debris type	Textured Coating To Ceiling
Extent	6 m ²
	■ No Risk

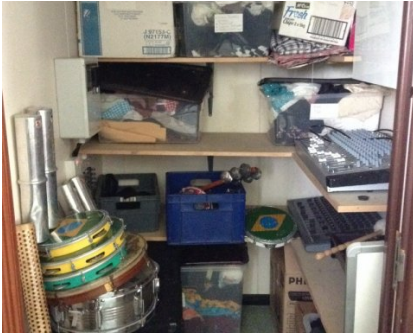
Item ID	018(VRS)
Sample/link ID	S006
Property Name	Valley Gardens Middle
Area/floor	EB
Room/location	EB023
Specific location	Ceiling
Product/debris type	Textured Coating To Ceiling
Extent	38 m ²
	■ No Risk

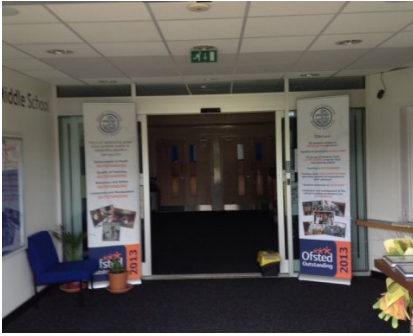
Item ID	019(VRS)
Sample/link ID	S006
Property Name	Valley Gardens Middle
Area/floor	EB
Room/location	EB023A
Specific location	Ceiling
Product/debris type	Textured Coating To Ceiling
Extent	3 m ²
	■ No Risk

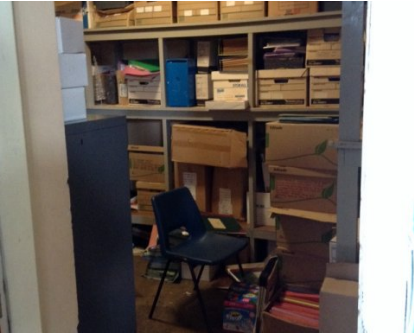
Product Type (a)	1
Extent of Damage (b)	1
Surface Treatment (c)	0
Asbestos Fibre (d)	1
Total (a+b+c+d)	03
Material Risk Assessment	■ Very Low

Manage & Annually Re-inspect

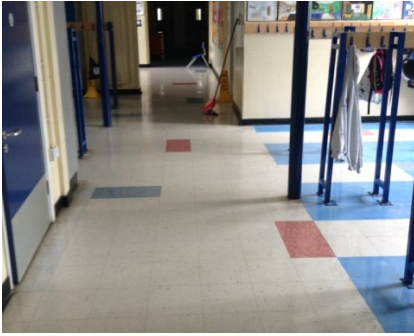
Modern MMMF insulation to high level pipework.

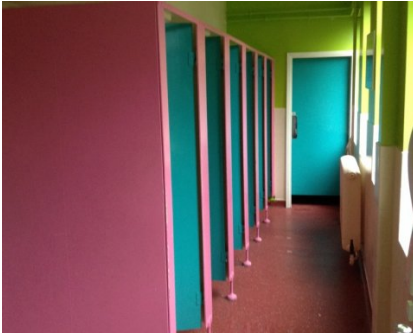
No access beneath modern non slip linoleum due to excess damage. No access within timber box work due to excess damage.

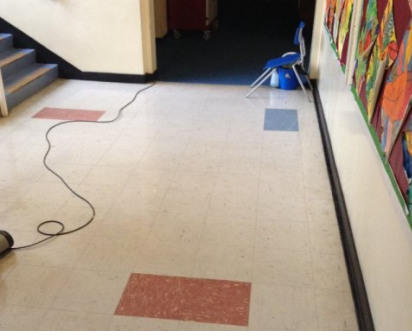
No access beneath modern non slip linoleum due to excess damage. No access within timber box work due to excess damage.

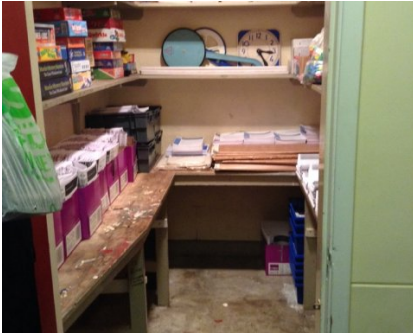
Limited access beneath carpet.

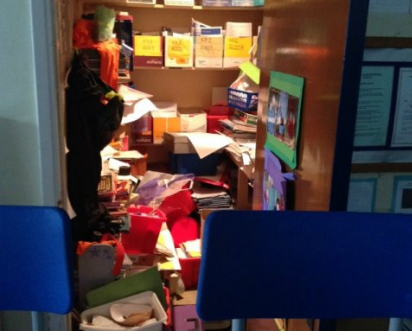
Limited access beneath carpet.

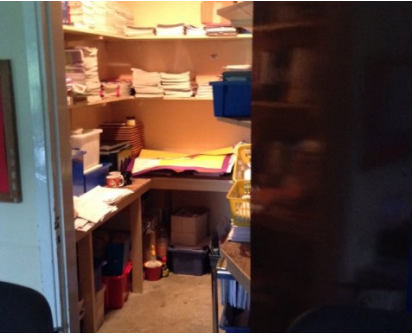
Limited access beneath carpet.

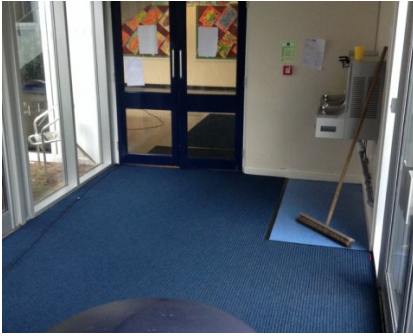
Limited access beneath carpet.

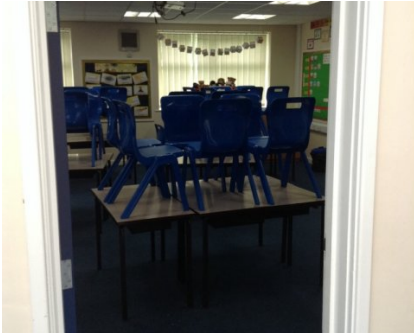
No access beneath modern linoleum flooring due to excess damage.

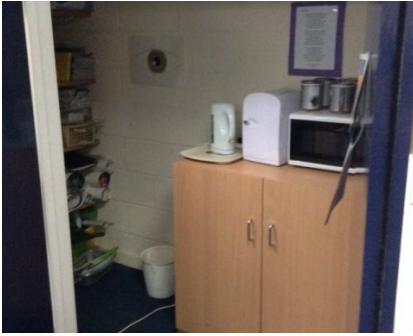
No access beneath modern carpet and linoleum flooring due to excess damage.

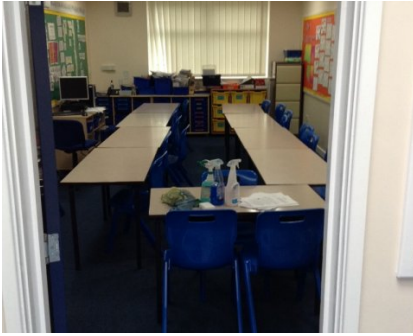
No access beneath modern linoleum flooring due to excess damage. No access within low level timber box work due to excess damage.

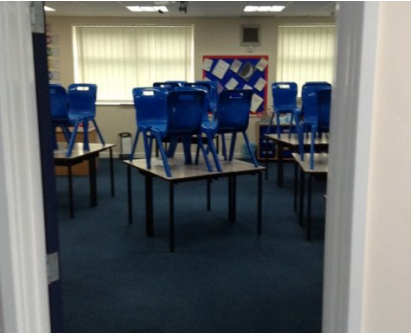
No access beneath modern carpet due to excess damage.

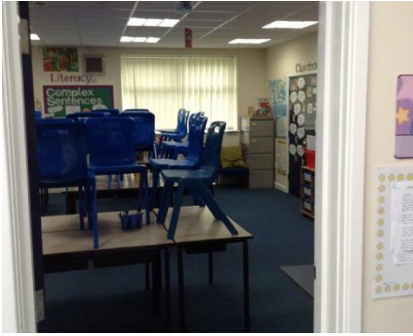
No access beneath modern carpet and linoleum flooring due to excess damage.

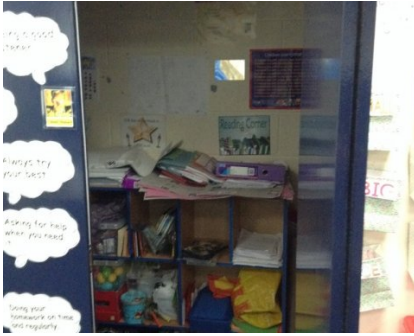
No access beneath modern carpet and linoleum flooring due to excess damage.

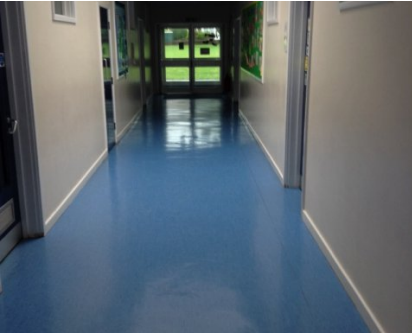
No access beneath modern carpet due to excess damage.

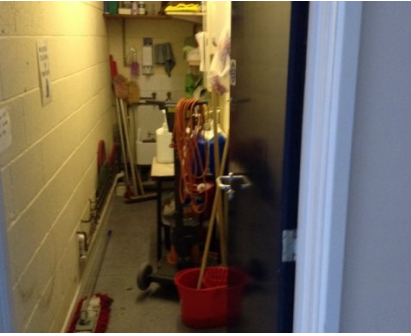
No access beneath modern linoleum flooring due to excess damage.

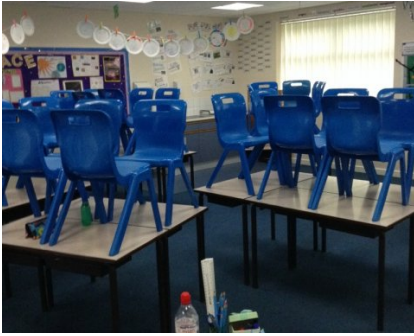
No access beneath modern linoleum flooring due to excess damage. MMMF insulation to pipe work above suspended ceiling. Modern electric switch gear.

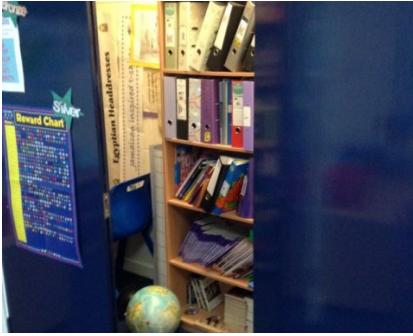
No access beneath modern carpet and linoleum flooring due to excess damage.

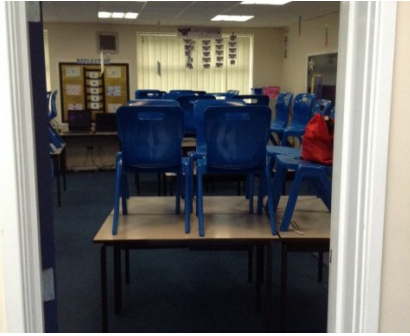
No access beneath carpet due to excess damage. No access within low level timber boxing.

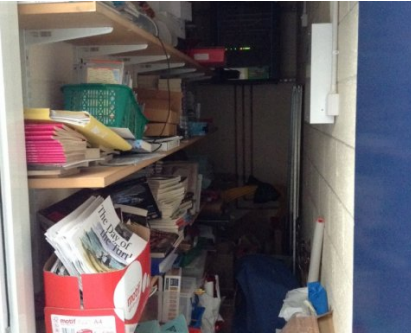
No access beneath carpet due to excess damage. No access within low level timber boxing.

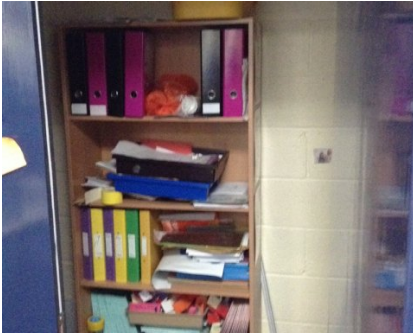
No access beneath modern carpet and linoleum flooring due to excess damage.

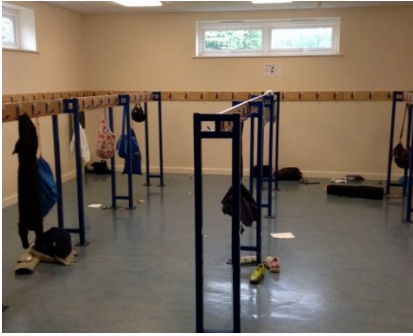
No access beneath carpet due to excess damage. No access within low level timber boxing.

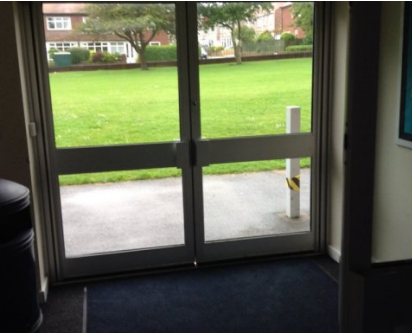
No access beneath modern linoleum flooring due to excess damage.

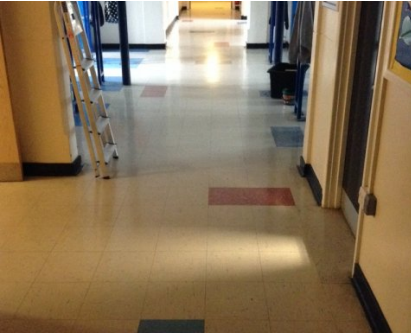
No access beneath carpet due to excess damage.

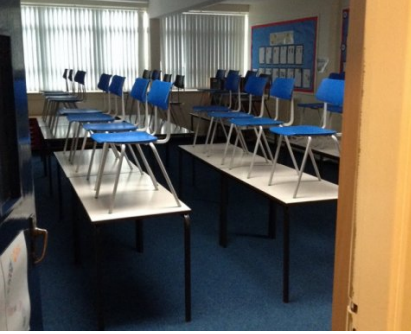
Product Type (a)	1
Extent of Damage (b)	1
Surface Treatment (c)	0
Asbestos Fibre (d)	1
Total (a+b+c+d)	03
Material Risk Assessment	■ Very Low

Normal Occupant Activity (e)	1
Likelihood of Disturbance (f)	1
Human Exposure Potential (g)	1
Maintenance Activity (h)	1
Total (e+f+g+h)	04
Priority Risk Assessment	■ Very Low

Location
 Item ID 007(OS)
 Sample/link ID S003
 Property Name Valley Gardens Middle
 Area/floor G
 Room/location G045A
 Specific location Floor
 Product/debris type Flooring Floor Tile(s)
 Asbestos type Identified Chrysotile
 Extent 3 m²
 Accessibility /vulnerability Medium
 Additional information N/A
 Air Test -
Actions/recommendations
 Action/recommendations Manage & Annually Re-inspect

Material Assessment
 Product Type (a) 1
 Extent of Damage (b) 1
 Surface Treatment (c) 0
 Asbestos Fibre (d) 1
 Total (a+b+c+d) 03
 Material Risk Assessment Very Low
Priority Assessment
 Normal Occupant Activity (e) 1
 Likelihood of Disturbance (f) 1
 Human Exposure Potential (g) 1
 Maintenance Activity (h) 1
 Total (e+f+g+h) 04
 Priority Risk Assessment Very Low
Overall Assessment
 Total (a+b+c+d+e+f+g+h) 07
 Overall Risk Assessment Very Low
Comments
 No Comments

Action/recommendations	Manage & Annually Re-inspect
------------------------	------------------------------

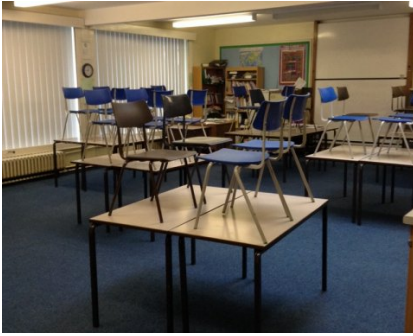
Product Type (a)	1
Extent of Damage (b)	1
Surface Treatment (c)	0
Asbestos Fibre (d)	1
Total (a+b+c+d)	03
Material Risk Assessment	Very Low

Normal Occupant Activity (e)	1
Likelihood of Disturbance (f)	1
Human Exposure Potential (g)	1
Maintenance Activity (h)	1
Total (e+f+g+h)	04
Priority Risk Assessment	Very Low

Location
 Item ID 008(VRS)
 Sample/link ID S003
 Property Name Valley Gardens Middle
 Area/floor G
 Room/location G046A
 Specific location Floor
 Product/debris type Flooring Floor Tile(s)
 Asbestos type Identified Chrysotile
 Extent 2 m²
 Accessibility /vulnerability Low
 Additional information N/A
 Air Test -
Actions/recommendations
 Action/recommendations Manage & Annually Re-inspect

Material Assessment
 Product Type (a) 1
 Extent of Damage (b) 1
 Surface Treatment (c) 0
 Asbestos Fibre (d) 1
 Total (a+b+c+d) 03
 Material Risk Assessment Very Low
Priority Assessment
 Normal Occupant Activity (e) 1
 Likelihood of Disturbance (f) 1
 Human Exposure Potential (g) 1
 Maintenance Activity (h) 1
 Total (e+f+g+h) 04
 Priority Risk Assessment Very Low
Overall Assessment
 Total (a+b+c+d+e+f+g+h) 07
 Overall Risk Assessment Very Low
Comments
 No Comments

Action/recommendations	Manage & Annually Re-inspect
------------------------	------------------------------

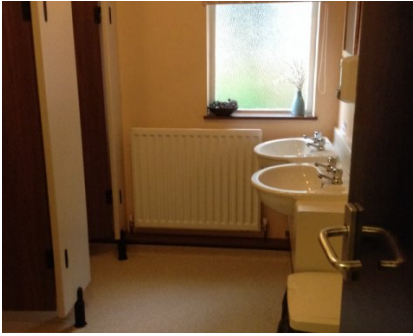
No access within timber boxing. No access beneath modern linoleum due to damage.

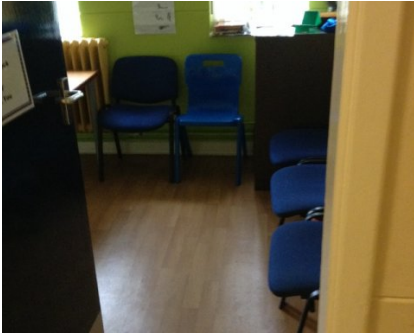
No access within timber boxing. No access beneath modern linoleum due to damage.

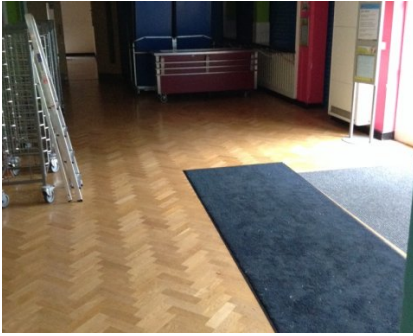
No access beneath modern linoleum due to damage.

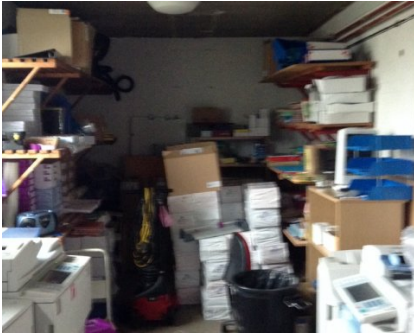
No access beneath modern linoleum due to damage.

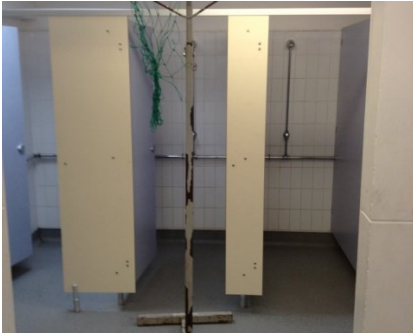
Room/location Reference:	G060A
Room/location Description:	Changing Room Showers
Area/floor Reference:	G
Area/floor Description:	Ground Floor
Accessibility:	Accessible

No access beneath modern linoleum due to damage. No access within high level timber boxing.

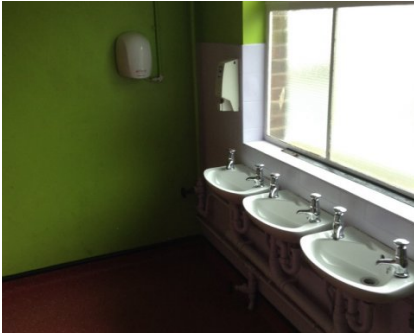
Room/location Reference:	G061
Room/location Description:	Girls W.C.
Area/floor Reference:	G
Area/floor Description:	Ground Floor
Accessibility:	Accessible
Total ACMs:	0
Total NoACMs:	0

High level MMMF pipe insulation.

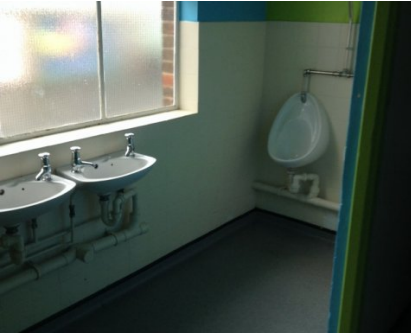
Room/location Reference:	G067
Room/location Description:	Boys W.C.
Area/floor Reference:	G
Area/floor Description:	Ground Floor
Accessibility:	Accessible
Total ACMs:	0
Total NoACMs:	0

No access beneath modern linoleum flooring due to excessive damage.

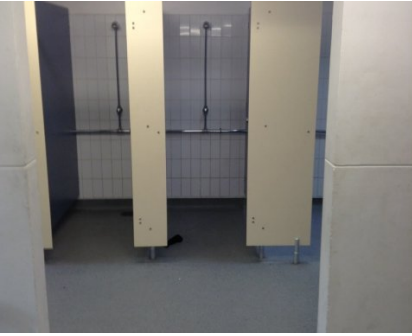
Room/location Reference:	G068A
Room/location Description:	Changing Room Showers
Area/floor Reference:	G
Area/floor Description:	Ground Floor
Accessibility:	Accessible
Total ACMs:	0
Total NoACMs:	0

No access beneath modern linoleum due to damage.

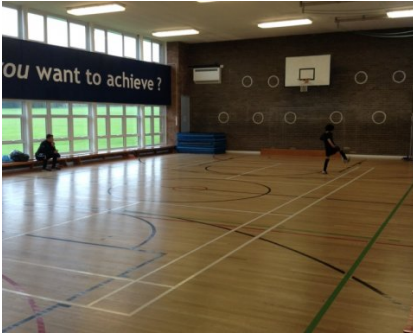
Room/location Reference:	G069
Room/location Description:	Gymnasium
Area/floor Reference:	G
Area/floor Description:	Ground Floor
Accessibility:	Accessible

No access within riser due to blocked access. No access beneath timber flooring due to excess damage. No access above high level fibreboard ceiling due to height.

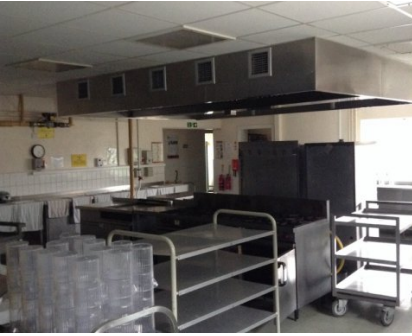
Room/location Reference:	G084
Room/location Description:	Kitchen
Area/floor Reference:	G
Area/floor Description:	Ground Floor
Accessibility:	Accessible
Total ACMs:	0
Total NoACMs:	0

No access beneath linoleum floor covering due to decorative damage.

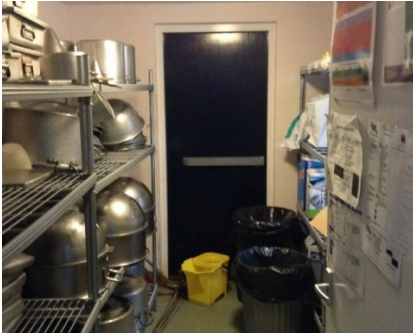
Room/location Reference:	G084A
Room/location Description:	Kitchen Store
Area/floor Reference:	G
Area/floor Description:	Ground Floor
Accessibility:	Accessible

No access beneath linoleum floor covering due to decorative damage.

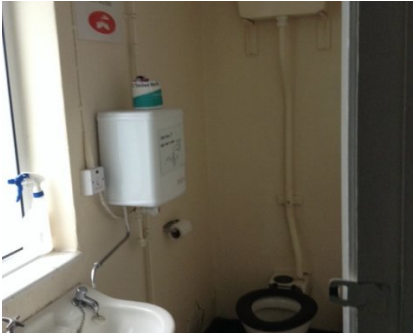
Room/location Reference:	G089
Room/location Description:	Kitchen W.C.
Area/floor Reference:	G
Area/floor Description:	Ground Floor
Accessibility:	Accessible
Total ACMs:	0
Total NoACMs:	0

No access beneath linoleum floor covering due to decorative damage.
